Single Survey

Survey report on:

Property Address	Cairmuir Muir Road Memsie Fraserburgh AB43 7AR
Customer	Mr J Jamieson & Ardlethen Developments Limited
Date of Inspection	30/01/2024
Prepared by	Keith Alexander Harvey Donaldson & Gibson Chartered Surveyors

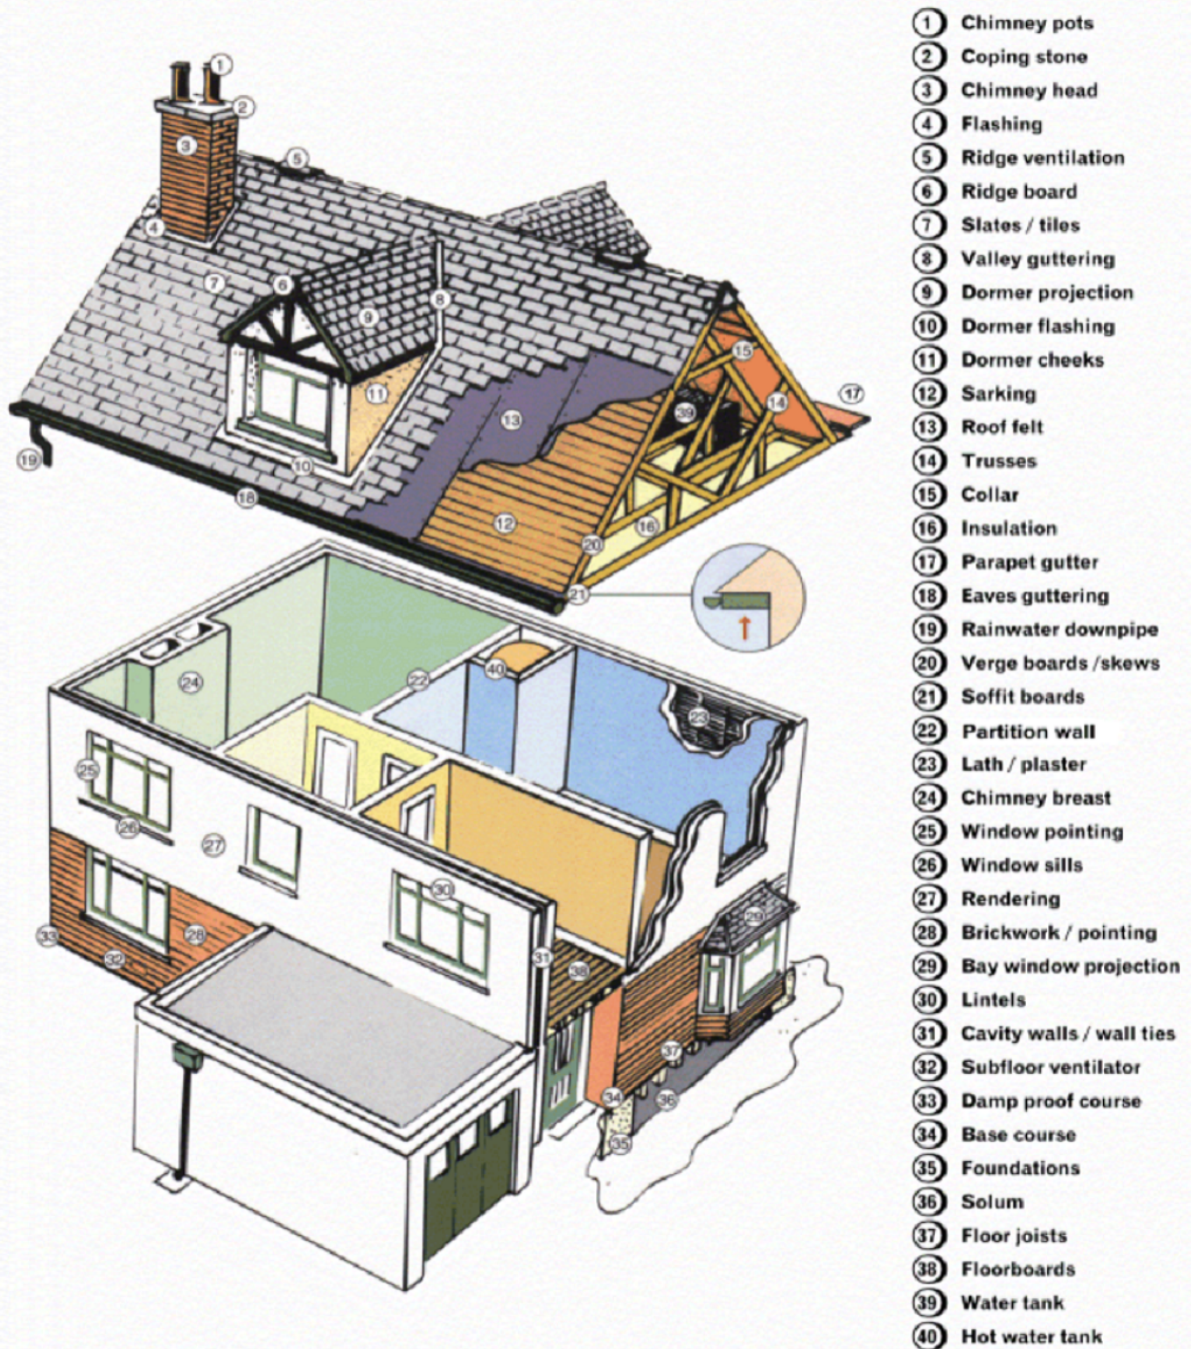
Sectional Diagram showing elements of a typical house

Reference may be made in this report to some or all of the above component parts of the property. This diagram may assist you in locating and understanding these items.
