HOME REPORT

49 DRUMCLOG CRESCENT
DARVEL
KA17 0BA

Energy Performance Certificate (EPC)

Single Survey

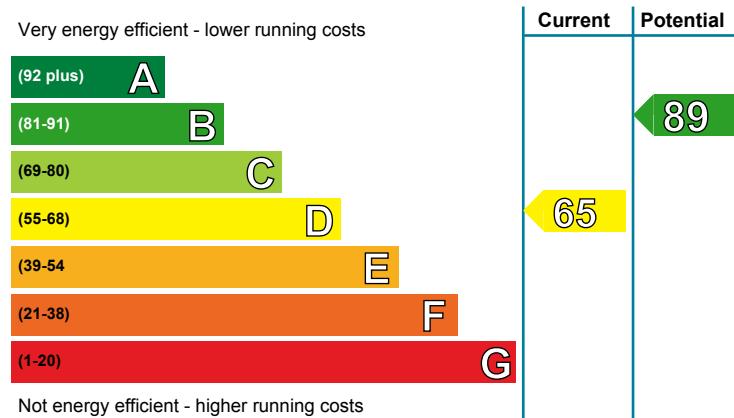
Energy Efficiency Rating

This graph shows the current efficiency of your home, taking into account both energy efficiency and fuel costs. The higher this rating, the lower your fuel bills are likely to be.

Your current rating is **band D (65)**. The average rating for EPCs in Scotland is **band D (61)**.

The potential rating shows the effect of undertaking all of the improvement measures listed within your recommendations report.

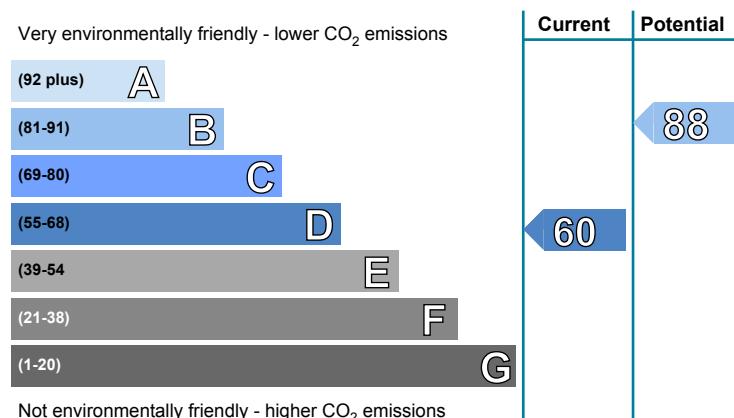
Environmental Impact (CO₂) Rating

This graph shows the effect of your home on the environment in terms of carbon dioxide (CO₂) emissions. The higher the rating, the less impact it has on the environment.

Your current rating is **band D (60)**. The average rating for EPCs in Scotland is **band D (59)**.

The potential rating shows the effect of undertaking all of the improvement measures listed within your recommendations report.
