Home Report

113 Irvine Road Kilmarnock KA1 2JZ

single survey

survey report on:

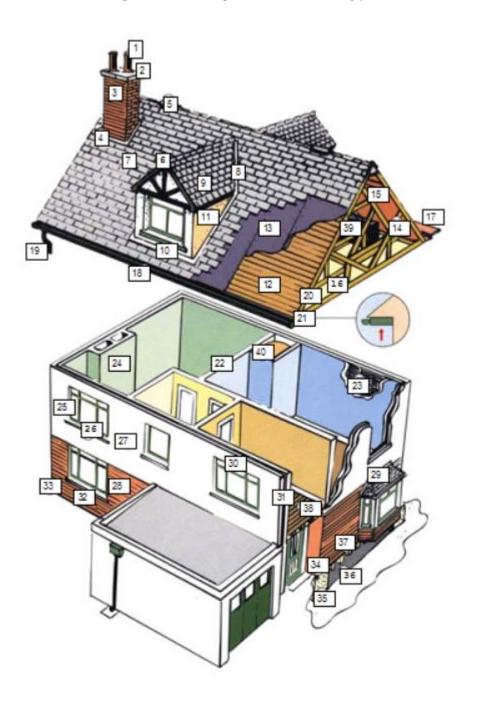
Sectional Diagram showing elements of a typical house

Flashing 4 Ridge ventilation 5 Ridge board Slates/tiles 8 Valley guttering 9 Dormer projection Dormer flashing 10 Dormer cheeks 11 12 Sarking Roof felt 13 Trusses 14 15 Collar 16 Insulation 17 Parapet gutter Eaves guttering 18 Rainwater downpipe 19 20 Verge boards / skews 21 Soffit boards 22 Partition wall Lath / plaster 23 24 Chimney breast 25 Window pointing Window sills 26 Rendering 27 Brickwork / pointing 28
