# HOME REPORT

UPPER FLAT  
7 NORTH BURNSIDE  
CUPAR  
KY15 4BQ

# Energy Performance Certificate (EPC)

**Dwelling type:** Top-floor maisonette  
**Date of assessment:** 05 December 2024  
**Date of certificate:** 11 December 2024  
**Total floor area:** 82 m<sup>2</sup>  
**Primary Energy Indicator:** 516 kWh/m<sup>2</sup>/year

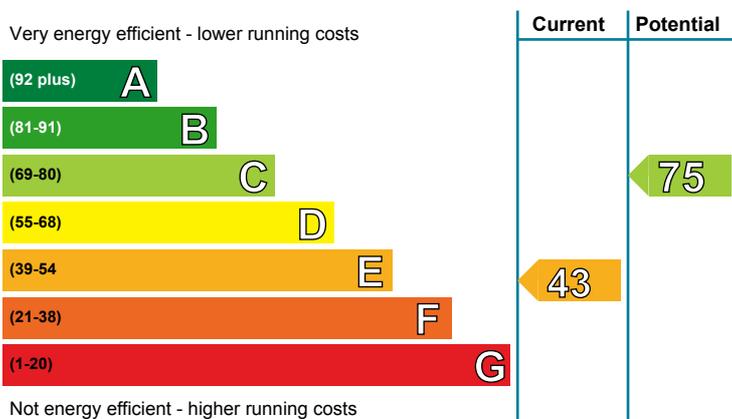
## Energy Efficiency Rating

This graph shows the current efficiency of your home, taking into account both energy efficiency and fuel costs. The higher this rating, the lower your fuel bills are likely to be.

Your current rating is **band E (43)**. The average rating for EPCs in Scotland is **band D (61)**.

The potential rating shows the effect of undertaking all of the improvement measures listed within your recommendations report.

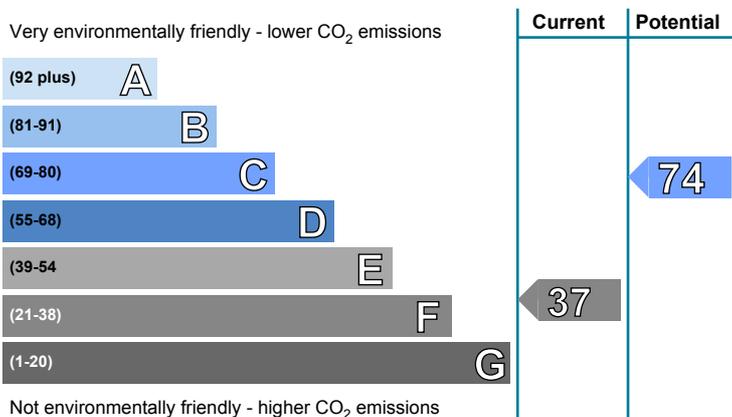
## Environmental Impact (CO<sub>2</sub>) Rating

This graph shows the effect of your home on the environment in terms of carbon dioxide (CO<sub>2</sub>) emissions. The higher the rating, the less impact it has on the environment.

Your current rating is **band F (37)**. The average rating for EPCs in Scotland is **band D (59)**.

The potential rating shows the effect of undertaking all of the improvement measures listed within your recommendations report.
