HOME REPORT

5C
5 STEVENSON STREET
BONNYTON
KILMARNOCK
KA1 2RF

Energy Performance Certificate (EPC)

Single Survey

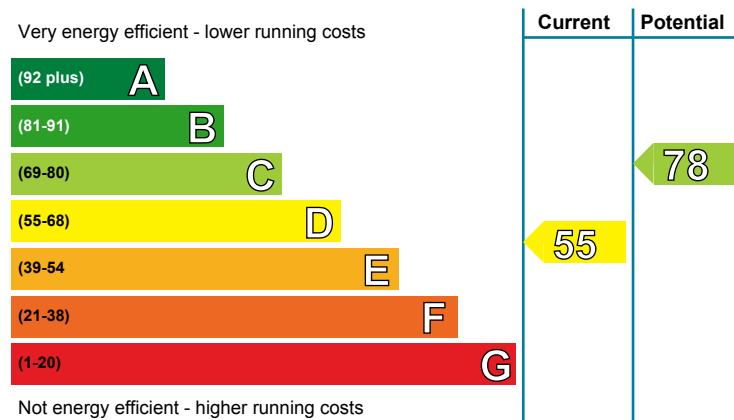
Energy Efficiency Rating

This graph shows the current efficiency of your home, taking into account both energy efficiency and fuel costs. The higher this rating, the lower your fuel bills are likely to be.

Your current rating is **band D (55)**. The average rating for EPCs in Scotland is **band D (61)**.

The potential rating shows the effect of undertaking all of the improvement measures listed within your recommendations report.

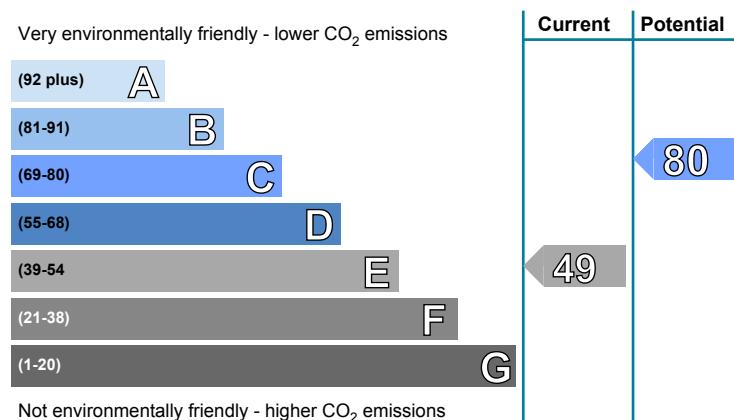
Environmental Impact (CO₂) Rating

This graph shows the effect of your home on the environment in terms of carbon dioxide (CO₂) emissions. The higher the rating, the less impact it has on the environment.

Your current rating is **band E (49)**. The average rating for EPCs in Scotland is **band D (59)**.

The potential rating shows the effect of undertaking all of the improvement measures listed within your recommendations report.
