HOME REPORT

Clarewood
Woodhead Street
High Valleyfield
Dunfermline
KY12 8SH

DM HALL
CHARTERED SURVEYORS

Single Survey

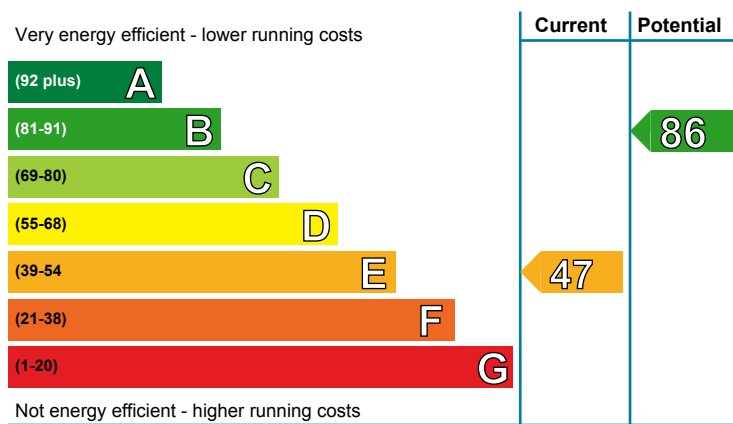
Energy Efficiency Rating

This graph shows the current efficiency of your home, taking into account both energy efficiency and fuel costs. The higher this rating, the lower your fuel bills are likely to be.

Your current rating is **band E (47)**. The average rating for EPCs in Scotland is **band D (61)**.

The potential rating shows the effect of undertaking all of the improvement measures listed within your recommendations report.

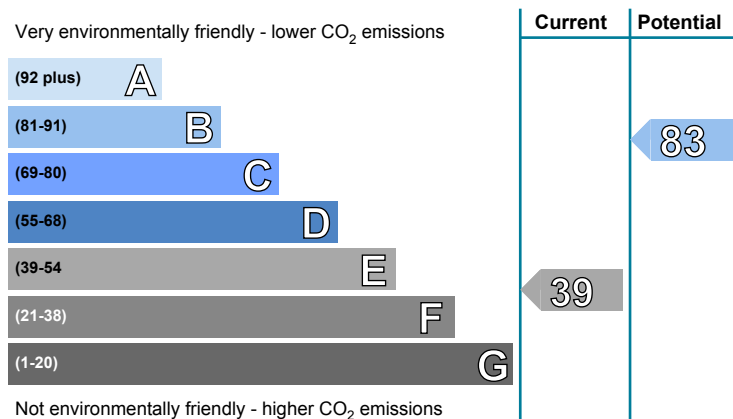
Environmental Impact (CO₂) Rating

This graph shows the effect of your home on the environment in terms of carbon dioxide (CO₂) emissions. The higher the rating, the less impact it has on the environment.
