HOME
report

SINGLE SURVEY
ENERGY REPORT
PROPERTY QUESTIONNAIRE
VALUATION REPORT

Property Address	Ross Mor Woodlands Terrace Grantown-On-Spey PH26 3JU
Customer	Mr T Baxter
Date of Inspection	23/04/2024
Prepared by	John I Dougan Harvey Donaldson & Gibson Chartered Surveyors

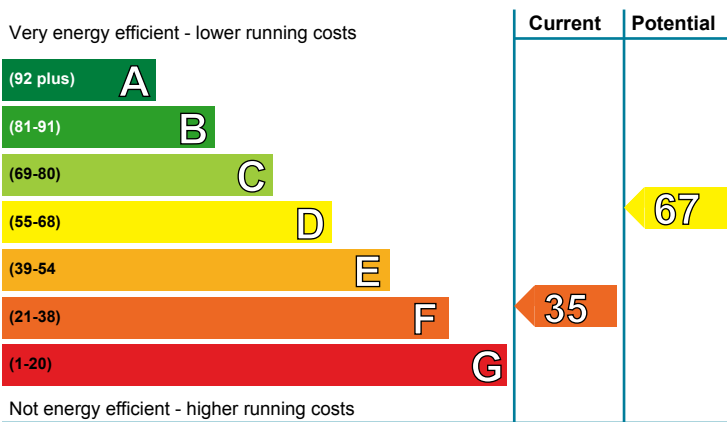
Energy Efficiency Rating

This graph shows the current efficiency of your home, taking into account both energy efficiency and fuel costs. The higher this rating, the lower your fuel bills are likely to be.

Your current rating is **band F (35)**. The average rating for EPCs in Scotland is **band D (61)**.

The potential rating shows the effect of undertaking all of the improvement measures listed within your recommendations report.
