# Home Report

9 Macleod Place Kilmarnock KA3 7EY

# single survey

# survey report on:

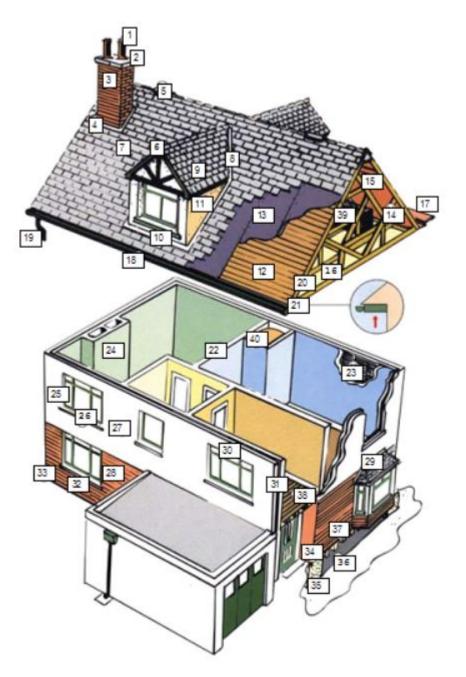
# Sectional Diagram showing elements of a typical house

Reference may be made in this report to some or all of the above component parts of the property. This diagram may assist you in locating and understanding these items.

1	Chimney pots
2	Coping stone
3	Chimney head
4	Flashing
5	Ridge ventilation
6	Ridge board

35 Foundations36 Solum
