HOME REPORT

37 WILSON AVENUE
KILMARNOCK
KA3 7AP

Energy Performance Certificate (EPC)

Single Survey

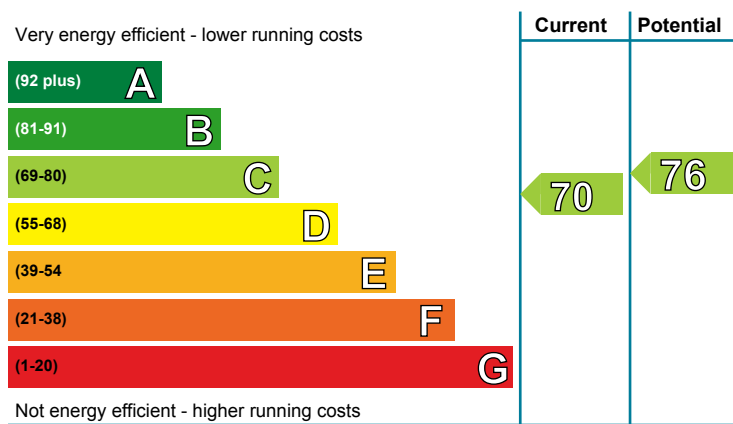
Energy Efficiency Rating

This graph shows the current efficiency of your home, taking into account both energy efficiency and fuel costs. The higher this rating, the lower your fuel bills are likely to be.

Your current rating is **band C (70)**. The average rating for EPCs in Scotland is **band D (61)**.

The potential rating shows the effect of undertaking all of the improvement measures listed within your recommendations report.
