Home Report

Single Survey

Flat 2 Derwent Court,
Kilmarnock,
East Ayrshire,
KA3 1HQ

SINGLE SURVEY TERMS AND CONDITIONS (WITH MVR)

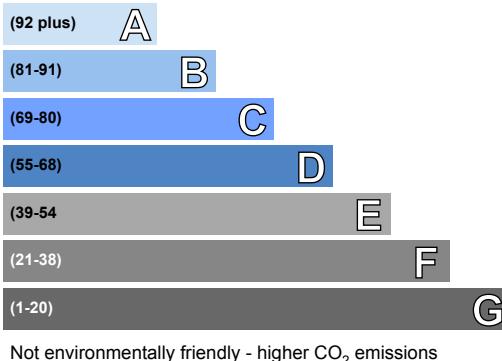
Very environmentally friendly - lower CO₂ emissions
