Home Report

26 Morton Place Kilmarnock KA1 2AY

Single Survey

Property Address	26 Morton Place Kilmarnock KA1 2AY
Customer	Craig Paton
Prepared by	Graham + Sibbald LLP
Date of Inspection	16/06/2025

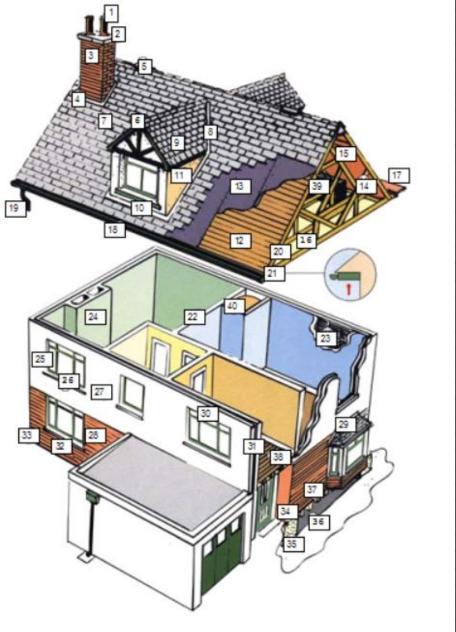
Sectional diagram showing elements of a typical house

1	Chimney pots	
2	Coping stone	
3	Chimney head	
4	Flashing	
5	Ridge ventilation	
6	Ridge board	
7	Slates / tiles	
8	Valley guttering	
9	Dormer projection	
10	Dormer flashing	
11	Dormer cheeks	
12	Sarking	
13	Roof felt	
14	Trusses	
15	Collar	
16	Insulation	
17	Parapet gutter	
18	Eaves guttering	
19	Rainwater downpipe	
20	Verge boards / skews	
21	Soffit boards	
22	Partition wall	
23	Lath / plaster	
24	Chimney breast	
25	Window pointing	
26	Window sills	
27	Rendering	
28	Brickwork / pointing	
29	Bay window projection	
30	Lintels	
31	Cavity walls / wall ties	
32	Subfloor ventilator	
33	Damp proof course	
34	Base course	
35	Foundations	
36	Solum	
37	Floor joists	
38	Floorboards	
39	Water tank	
40	Hot water tank

Reference may be made in this report to some or all of the above component parts of the property. This diagram may assist you in locating and understanding these items.
