18 Sunnybraes Terrace
Steelend
Dunfermline
KY12 9NE
20/02/2026

Home Report

Scottish Single Survey

Property address	18 Sunnybraes Terrace Steelend Dunfermline KY12 9NE
-------------------------	--

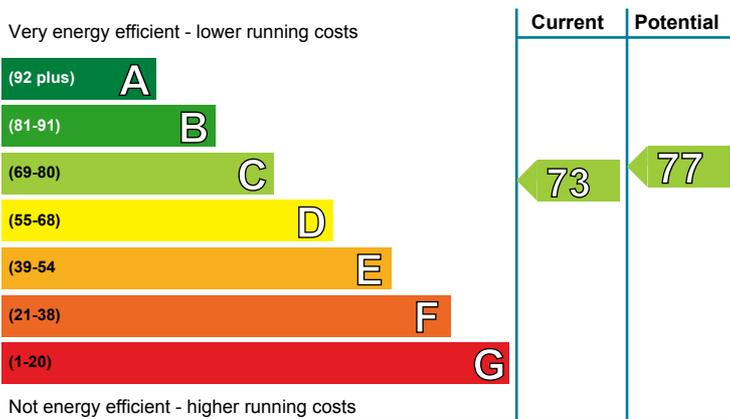
Energy Efficiency Rating

This graph shows the current efficiency of your home, taking into account both energy efficiency and fuel costs. The higher this rating, the lower your fuel bills are likely to be.

Your current rating is **band C (73)**. The average rating for EPCs in Scotland is **band D (61)**.

The potential rating shows the effect of undertaking all of the improvement measures listed within your recommendations report.
