# YOUR ONESURVEY HOME REPORT

17 Simpson Drive  
Maddiston, Falkirk  
FK2 0LS

# SINGLE SURVEY

A report on the condition of the property, with categories  
being rated from 1 to 3.

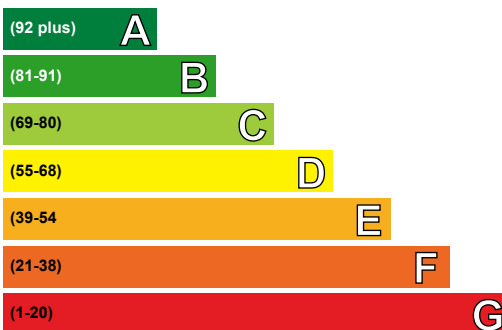
\* based upon the cost of energy for heating, hot water, lighting and ventilation, calculated using standard assumptions

Very energy efficient - lower running costs

Not energy efficient - higher running costs

The potential rating shows the effect of undertaking all of the improvement measures listed within your recommendations report.

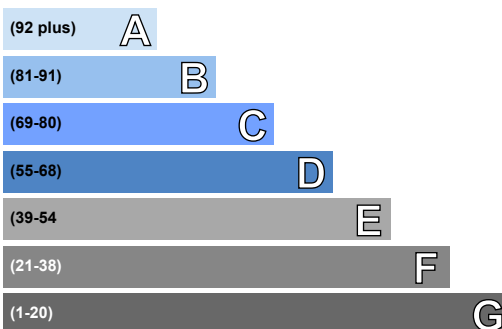
Very environmentally friendly - lower CO<sub>2</sub> emissions

Not environmentally friendly - higher CO<sub>2</sub> emissions
