Single Survey

Property address	98 Stirling Road, Milnathort, Kinross, KY13 9XR
-------------------------	--

Prepared by	DHKK Chartered Surveyors
--------------------	--------------------------

Date of inspection	28th April 2022
---------------------------	-----------------

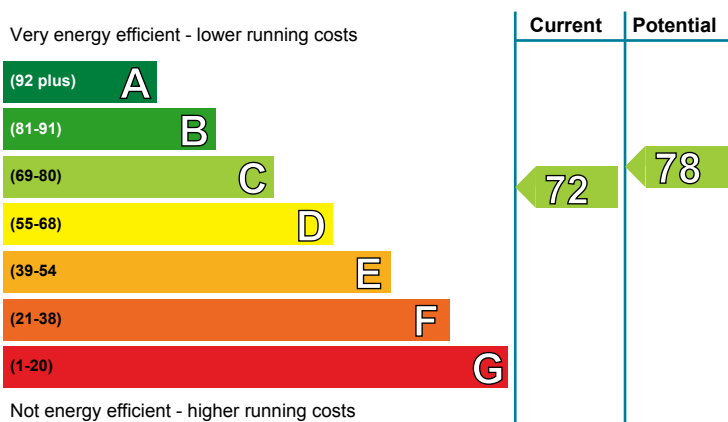
Energy Efficiency Rating

This graph shows the current efficiency of your home, taking into account both energy efficiency and fuel costs. The higher this rating, the lower your fuel bills are likely to be.

Your current rating is **band C (72)**. The average rating for EPCs in Scotland is **band D (61)**.

The potential rating shows the effect of undertaking all of the improvement measures listed within your recommendations report.
