HOME REPORT

80 BEECHWOOD ROAD
MAUCHLINE
KA5 6DN

Energy Performance Certificate (EPC)

80 BEECHWOOD ROAD, MAUCHLINE, KA5 6DN

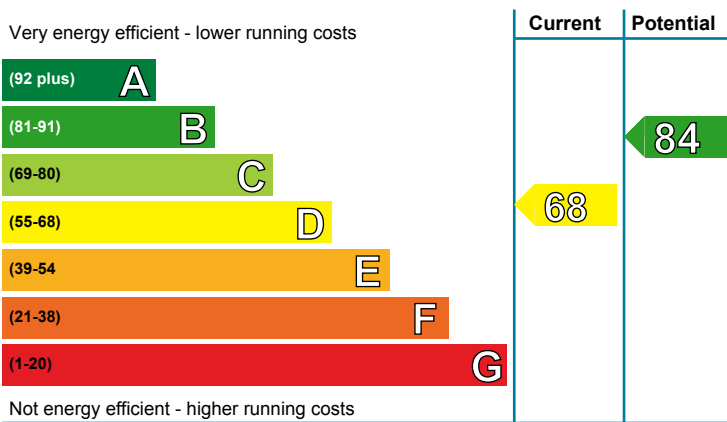
Energy Efficiency Rating

This graph shows the current efficiency of your home, taking into account both energy efficiency and fuel costs. The higher this rating, the lower your fuel bills are likely to be.

Your current rating is **band D (68)**. The average rating for EPCs in Scotland is **band D (61)**.

The potential rating shows the effect of undertaking all of the improvement measures listed within your recommendations report.
