# Home Report

# Single Survey

31 Dunlop Crescent,  
Dreghorn,  
Irvine,  
Ayrshire,  
KA11 4HN

## SINGLE SURVEY TERMS AND CONDITIONS (WITH MVR)

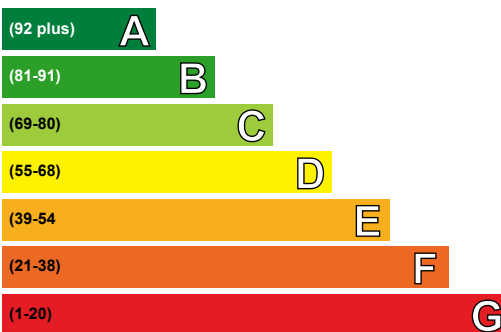
Very energy efficient - lower running costs

Not energy efficient - higher running costs

Current	Potential
83	83
