HOME REPORT

16A LINT RIGGS
FALKIRK
FK1 1DG

Energy Performance Certificate (EPC)

16A LINT RIGGS, FALKIRK, FK1 1DG

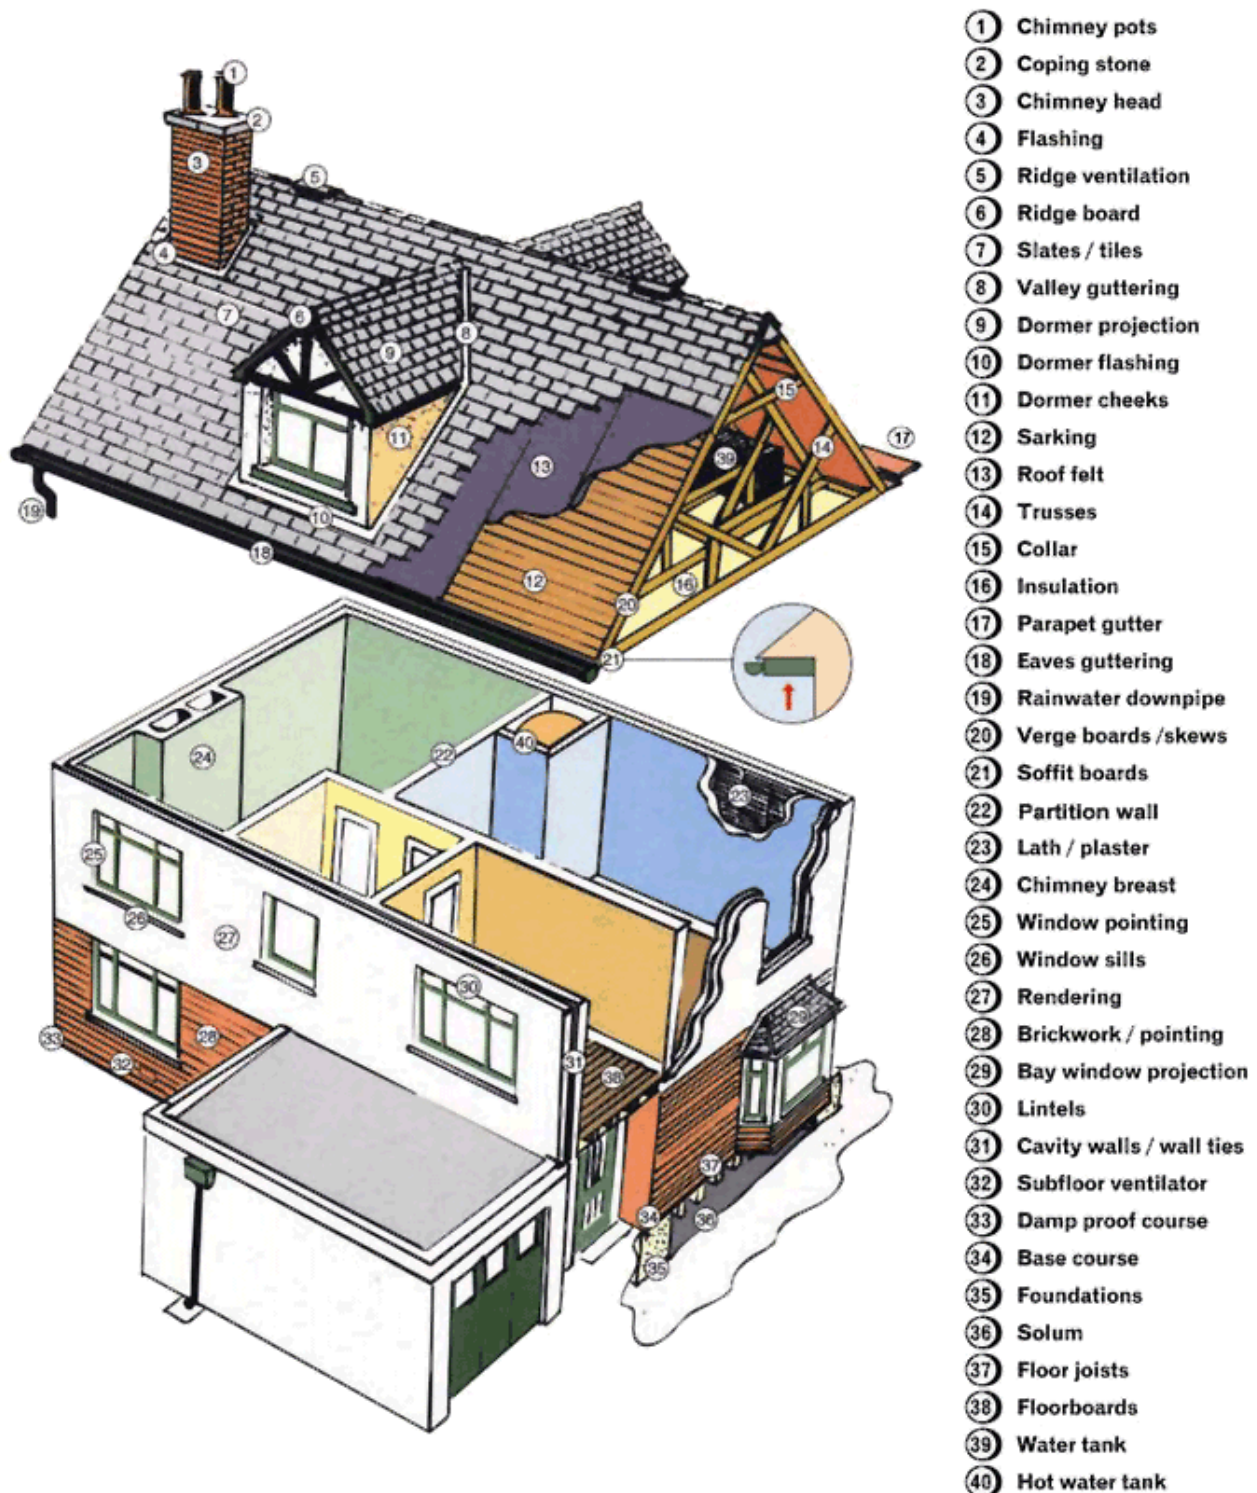
Sectional Diagram showing elements of a typical house

Reference may be made in this report to some or all of the above component parts of the property. This diagram may assist you in locating and understanding these items.
