HOME REPORT

36 BEECHWOOD ROAD
MAUCLINE
KA5 6DL

Energy Performance Certificate (EPC)

Single Survey

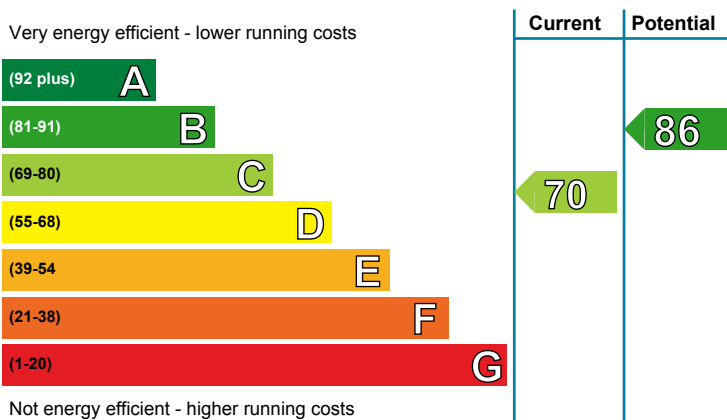
Energy Efficiency Rating

This graph shows the current efficiency of your home, taking into account both energy efficiency and fuel costs. The higher this rating, the lower your fuel bills are likely to be.

Your current rating is **band C (70)**. The average rating for EPCs in Scotland is **band D (61)**.

The potential rating shows the effect of undertaking all of the improvement measures listed within your recommendations report.
