Home Report

Survey Report on:

27 Barrmill Road, Galston, Ayrshire, KA4 8HH

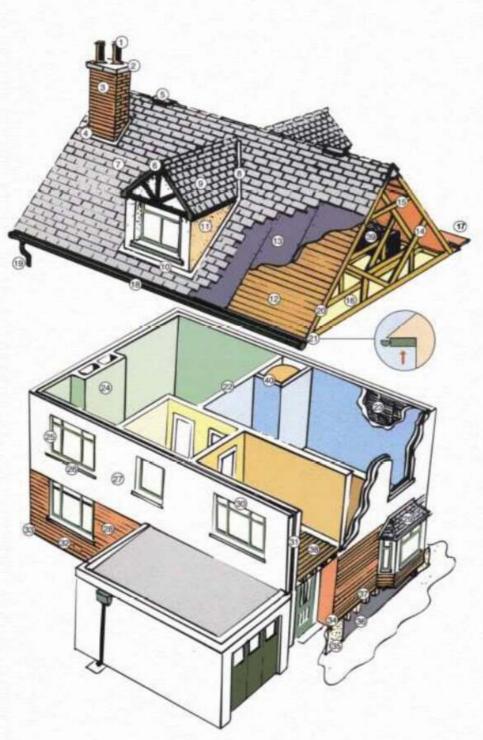
Sectional Diagram showing elements of a typical house

Reference may be made in this report to some or all of the above component parts of the property. This diagram may assist you in locating and understanding these items.

1	Chimney pots
2	Coping stone
3	Chimney head
1	Flashing
	Ridge ventilation
6	Ridge board
Ō	Slates / tiles
8	Valley guttering
9	Dormer projection
10	Dormer flashing
1	Dormer cheeks
12	Sarking
-	Roof felt
14	Trusses
15	Collar
16	Insulation
17	Parapet gutter
18	Eaves guttering
19	Rainwater downpipe
20	Verge boards /skews
21	Soffit boards
22	Partition wall
23	Lath / plaster
24	Chimney breast
25	Window pointing
26	Window sills
27	Rendering
28	Brickwork / pointing
29	Bay window projectio
30	Lintels
31	Cavity walls / wall ties
32	Subfloor ventilator
33	Damp proof course
34	Base course
35	Foundations
36	Solum
37	Floor joists
-	Floorboards
-	Water tank
40	Hot water tank
