Home Report

Scottish Single Survey

Property address	2/3 21 Boyd Street Glasgow G42 8AF
Customer	Neale Kinnear
Customer address	2/3 21 Boyd Street Glasgow G42 8AF
Prepared by	Shepherd Chartered Surveyors
Date of inspection	28/05/2024

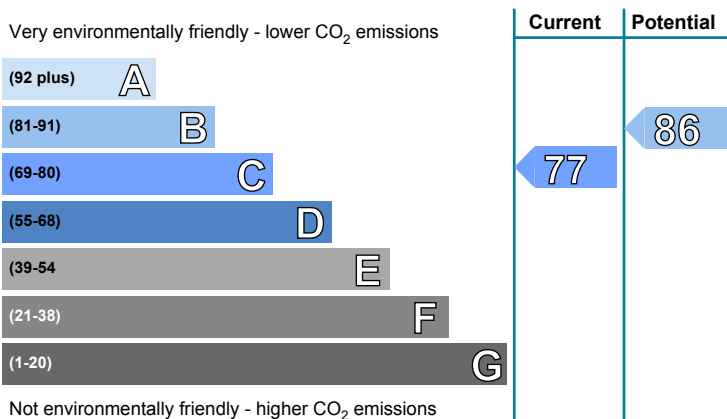
Environmental Impact (CO₂) Rating

This graph shows the effect of your home on the environment in terms of carbon dioxide (CO₂) emissions. The higher the rating, the less impact it has on the environment.
