HOME REPORT

1 CHRISTIE ROAD
ELGIN
IV30 4HB

ENERGY PERFORMANCE CERTIFICATE

SINGLE SURVEY

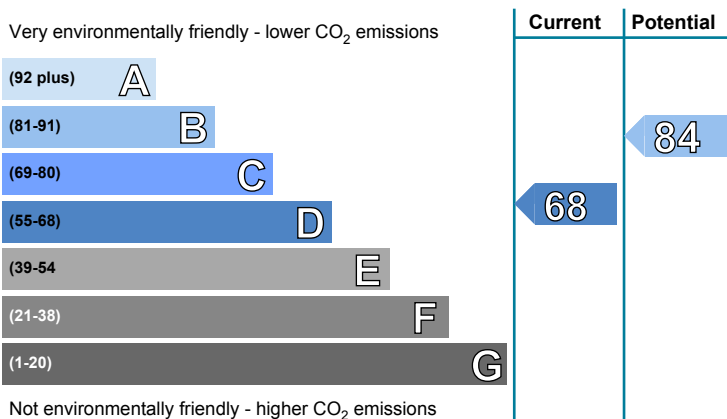
Environmental Impact (CO₂) Rating

This graph shows the effect of your home on the environment in terms of carbon dioxide (CO₂) emissions. The higher the rating, the less impact it has on the environment.

Your current rating is **band D (68)**. The average rating for EPCs in Scotland is **band D (59)**.

The potential rating shows the effect of undertaking all of the improvement measures listed within your recommendations report.
