YOUR ONESURVEY
HOME REPORT

42 Caprington Avenue
Kilmarnock
KA1 4SJ

SINGLE SURVEY

Surveyor Reference	MA/1031
Customer	Mr. Robert Armour
Selling address	42 Caprington Avenue Kilmarnock KA1 4SJ
Date of Inspection	30/03/2026
Prepared by	Nick Davis, MSc MRICS Kilmarnock - Allied Surveyors Scotland Ltd

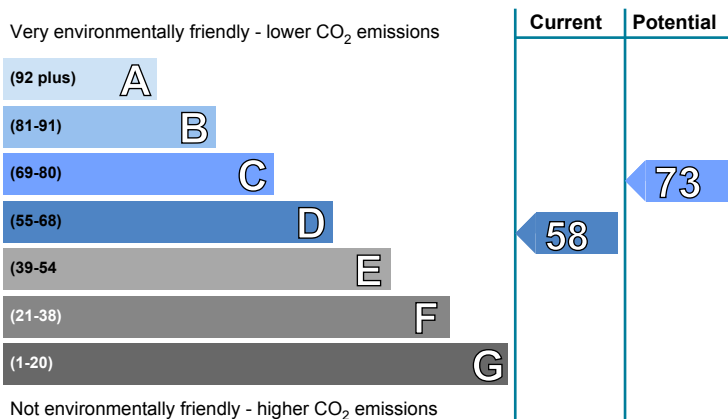
Environmental Impact (CO₂) Rating

This graph shows the effect of your home on the environment in terms of carbon dioxide (CO₂) emissions. The higher the rating, the less impact it has on the environment.
