10 Rannoch Road
Rosyth
Dunfermline
KY11 2AG
10/02/2026

Home Report

Scottish Single Survey

Property address	10 Rannoch Road Rosyth Dunfermline KY11 2AG
Customer	Mr John and Mrs Linda Mitchell
Customer address	
Prepared by	Shepherd Chartered Surveyors
Date of inspection	05/02/2026

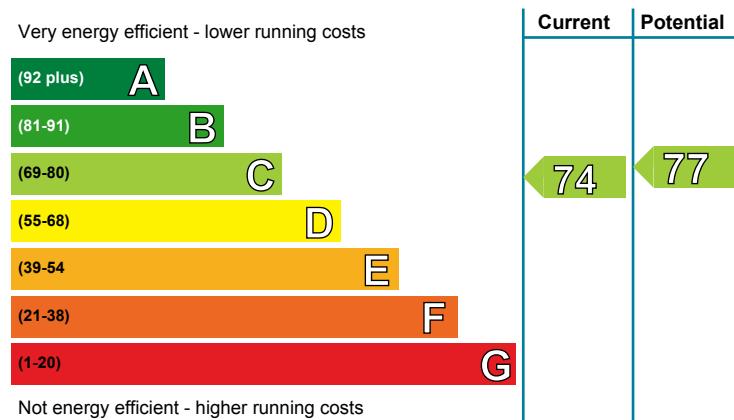
Energy Efficiency Rating

This graph shows the current efficiency of your home, taking into account both energy efficiency and fuel costs. The higher this rating, the lower your fuel bills are likely to be.

Your current rating is **band C (74)**. The average rating for EPCs in Scotland is **band D (61)**.

The potential rating shows the effect of undertaking all of the improvement measures listed within your recommendations report.
