YOUR ONESURVEY  
**HOME REPORT**

17 Pine Road  
Kilmarnock  
KA1 2EZ

# SINGLE SURVEY

A report on the condition of the property, with categories being rated from 1 to 3.

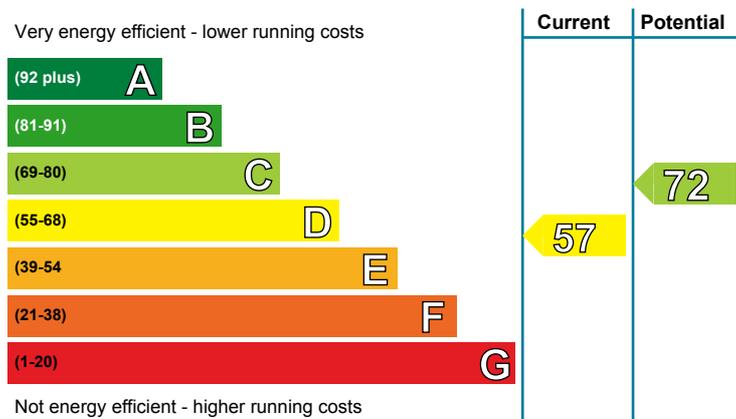
## Energy Efficiency Rating

This graph shows the current efficiency of your home, taking into account both energy efficiency and fuel costs. The higher this rating, the lower your fuel bills are likely to be.

Your current rating is **band D (57)**. The average rating for EPCs in Scotland is **band D (61)**.

The potential rating shows the effect of undertaking all of the improvement measures listed within your recommendations report.

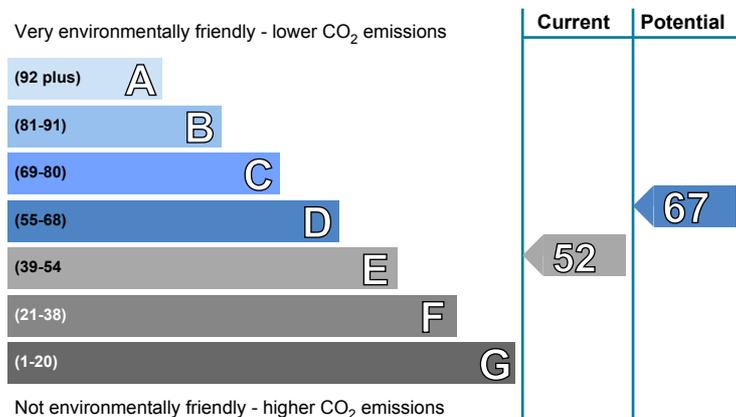
## Environmental Impact (CO<sub>2</sub>) Rating

This graph shows the effect of your home on the environment in terms of carbon dioxide (CO<sub>2</sub>) emissions. The higher the rating, the less impact it has on the environment.
