Single Survey

Property Address	3 Beechwood Gardens, Stirling, FK8 2AX
Customer	AMG
Date of Inspection	18/11/2025
Prepared by	A Little, MA (HONS) MRICS Connells Survey & Valuation Ltd

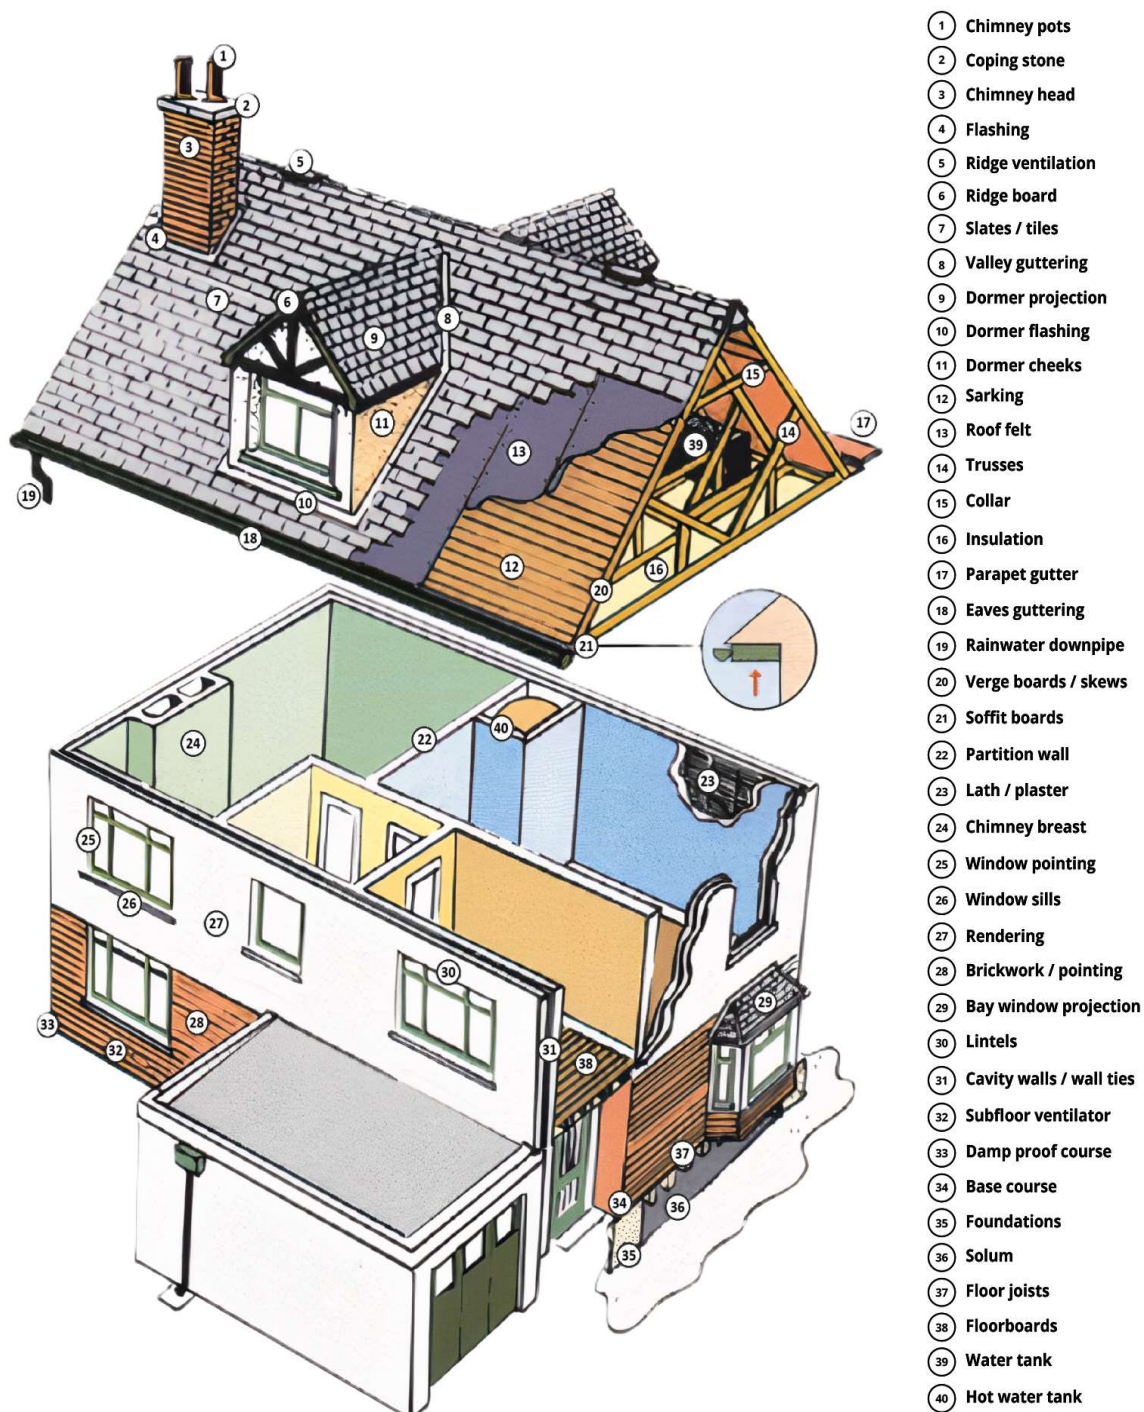
Sectional Diagram showing elements of a typical house

Reference may be made in this report to some or all of the above component parts of the property. This diagram may assist you in locating and understanding these items.
