Home Report

property questionnaire

| Property address | 46 Mearns Walk Laurencekirk AB30 1FA |

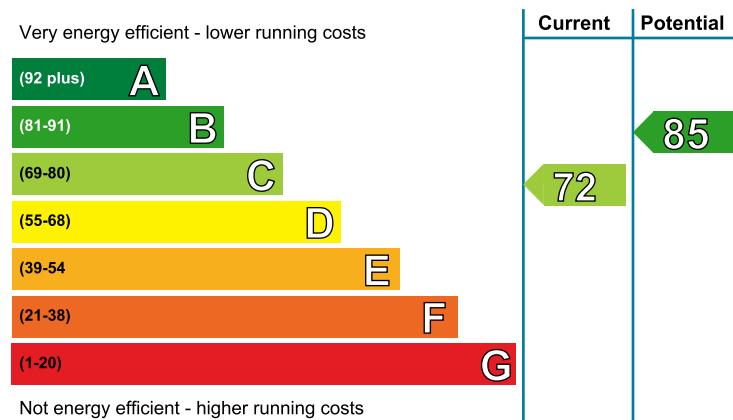
Energy Efficiency Rating

This graph shows the current efficiency of your home, taking into account both energy efficiency and fuel costs. The higher this rating, the lower your fuel bills are likely to be.

Your current rating is **band C (72)**. The average rating for EPCs in Scotland is **band D (61)**.

The potential rating shows the effect of undertaking all of the improvement measures listed within your recommendations report.

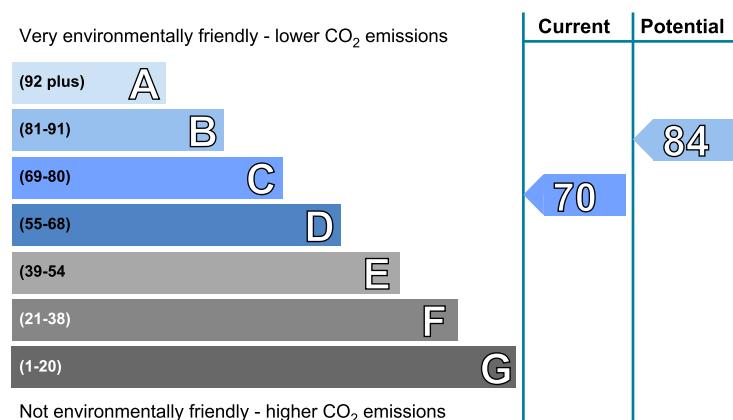
Environmental Impact (CO₂) Rating

This graph shows the effect of your home on the environment in terms of carbon dioxide (CO₂) emissions. The higher the rating, the less impact it has on the environment.

The potential rating shows the effect of undertaking all of the improvement measures listed within your recommendations report.

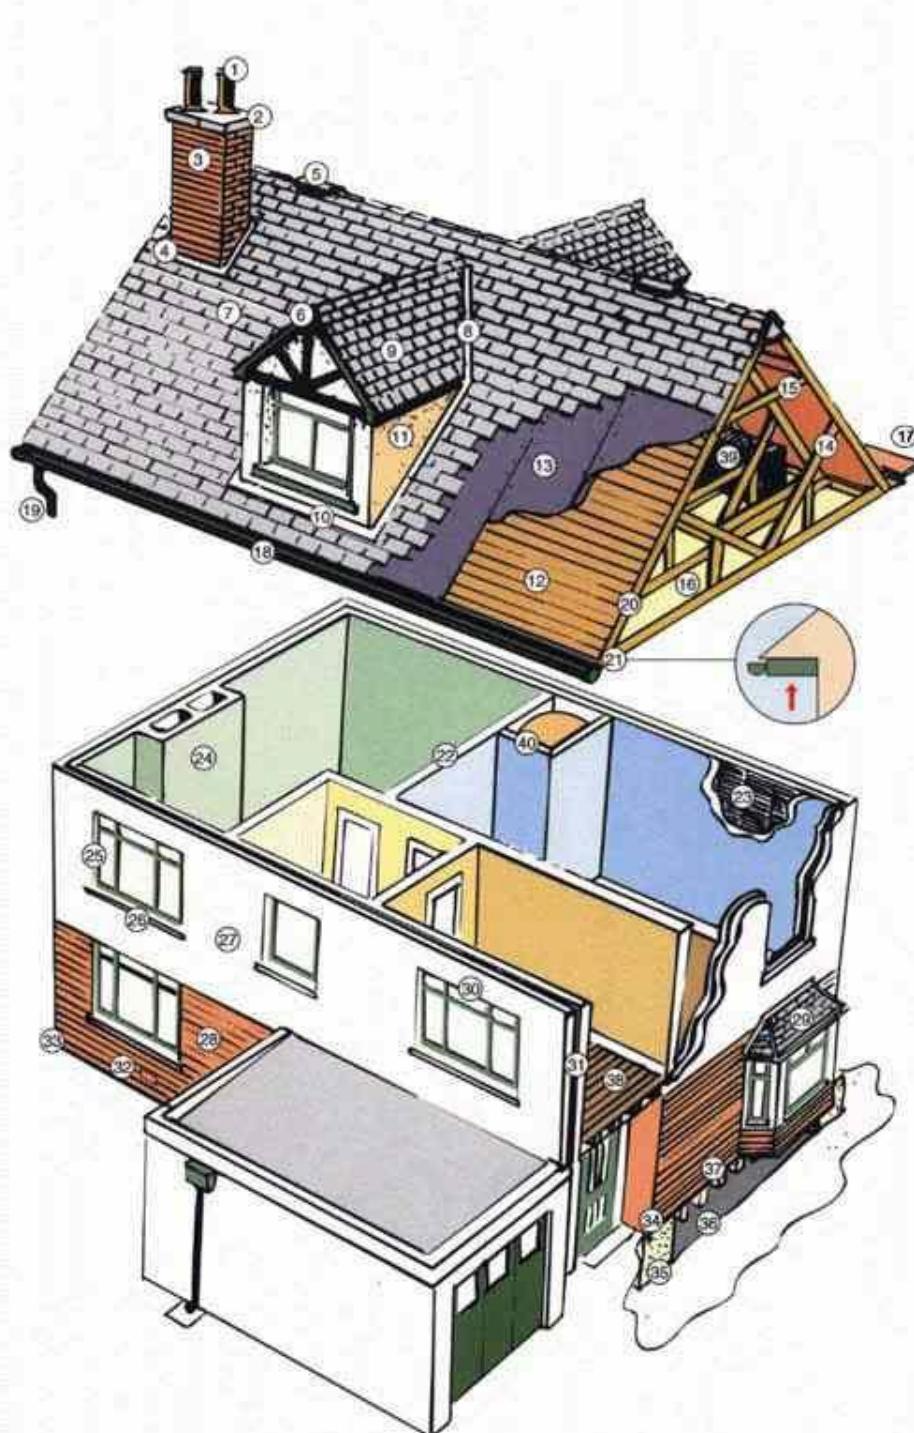
Sectional Diagram showing elements of a typical house

- 1 Chimney pots
- 2 Coping stone
- 3 Chimney head
- 4 Flashing
- 5 Ridge ventilation
- 6 Ridge board
- 7 Slates / tiles
- 8 Valley guttering
- 9 Dormer projection
- 10 Dormer flashing
- 11 Dormer cheeks
- 12 Sarking
- 13 Roof felt
- 14 Trusses
- 15 Collar
- 16 Insulation
- 17 Parapet gutter
- 18 Eaves guttering
- 19 Rainwater downpipe
- 20 Verge boards / skews
- 21 Soffit boards
- 22 Partition wall
- 23 Lath / plaster
- 24 Chimney breast
- 25 Window pointing
- 26 Window sills
- 27 Rendering
- 28 Brickwork / pointing
- 29 Bay window projection
- 30 Lintels
- 31 Cavity walls / wall ties
- 32 Subfloor ventilator
- 33 Damp proof course
- 34 Base course
- 35 Foundations
- 36 Solum
- 37 Floor joists
- 38 Floorboards
- 39 Water tank
- 40 Hot water tank

Reference may be made in this report to some or all of the above component parts of the property. This diagram may assist you in locating and understanding these items.
