YOUR ONESURVEY  
**HOME REPORT**

63b Charlotte Street  
Aberdeen  
AB25 1LU

# SINGLE SURVEY

A report on the condition of the property, with categories being rated from 1 to 3.

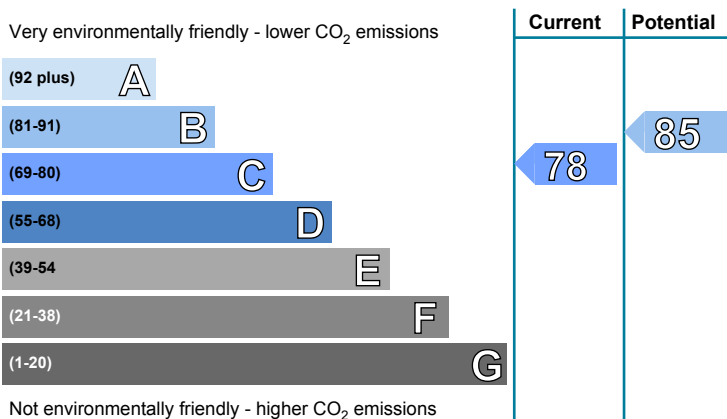
## Environmental Impact (CO<sub>2</sub>) Rating

This graph shows the effect of your home on the environment in terms of carbon dioxide (CO<sub>2</sub>) emissions. The higher the rating, the less impact it has on the environment.
