Home Report

Scottish Single Survey

Property address	11 Glebe Park Inverkeithing KY11 1LT
-------------------------	--

Prepared by	Shepherd Chartered Surveyors
--------------------	------------------------------

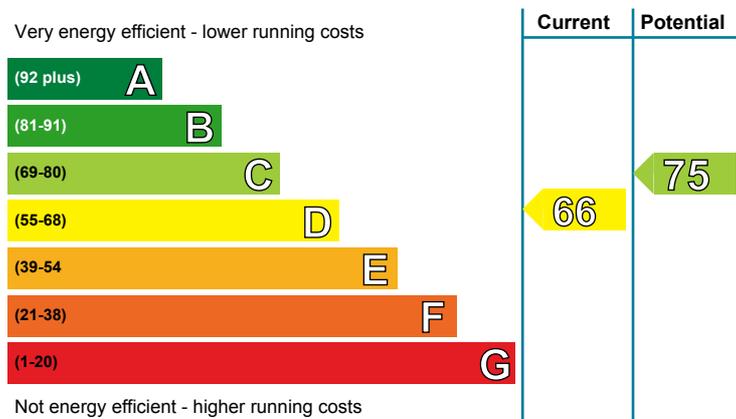
Energy Efficiency Rating

This graph shows the current efficiency of your home, taking into account both energy efficiency and fuel costs. The higher this rating, the lower your fuel bills are likely to be.

Your current rating is **band D (66)**. The average rating for EPCs in Scotland is **band D (61)**.

The potential rating shows the effect of undertaking all of the improvement measures listed within your recommendations report.

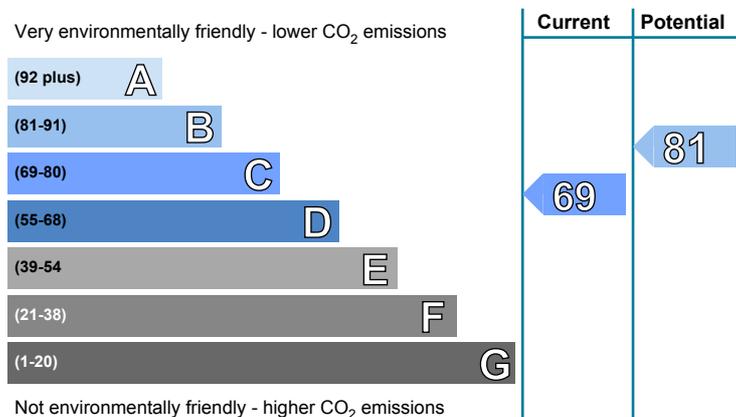
Environmental Impact (CO₂) Rating

This graph shows the effect of your home on the environment in terms of carbon dioxide (CO₂) emissions. The higher the rating, the less impact it has on the environment.
