HOME REPORT

FLAT 3
9 LIBERTON PLACE
ALNWICKHILL
EDINBURGH
EH16 6NA

Energy Performance Certificate (EPC)

Single Survey

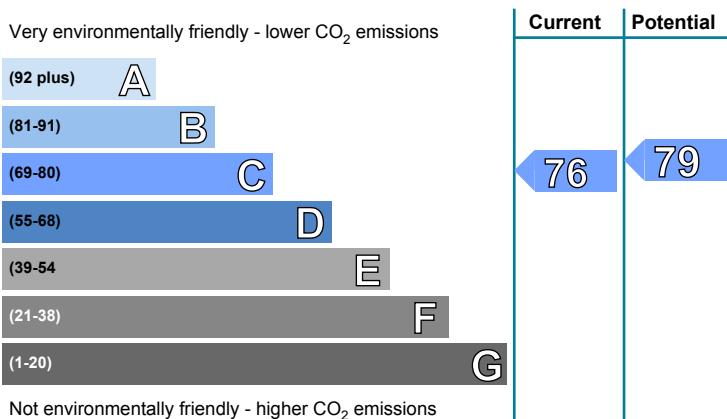
Environmental Impact (CO₂) Rating

This graph shows the effect of your home on the environment in terms of carbon dioxide (CO₂) emissions. The higher the rating, the less impact it has on the environment.

Your current rating is **band C (76)**. The average rating for EPCs in Scotland is **band D (59)**.

The potential rating shows the effect of undertaking all of the improvement measures listed within your recommendations report.
