Home Report

36 Andrew Lundie Place Galston KA4 8DQ

survey report on:

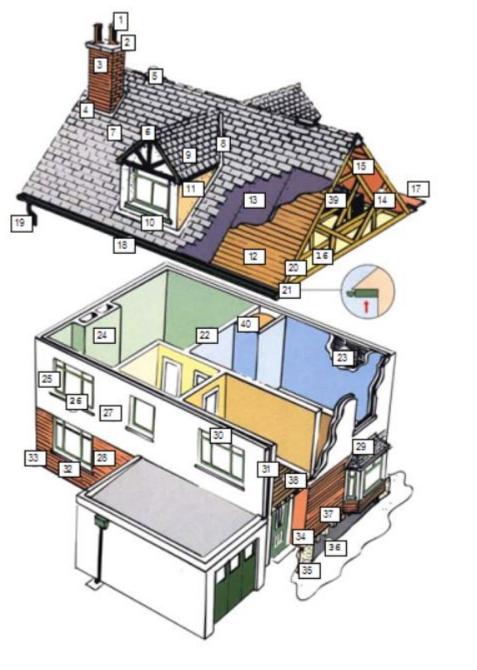
Sectional Diagram showing elements of a typical house

40 Reference may be made in this report to some or all of the above component parts of the property. This diagram may assist you in locating and understanding these items.
