Home Report

Cessnock Lodge Galston KA4 8LH

Property address	Cessnock Lodge
	Galston KA4 8LH
Customer	Alanna Mains
Prepared by	Graham + Sibbald LLP

Description	A mid-terraced single storey and attic former barn conversion.

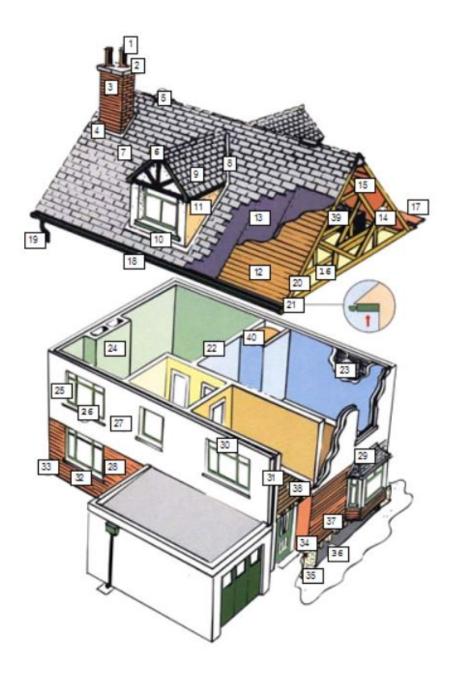
Sectional Diagram showing elements of a typical house

1	Chimney pots	
	• •	
2	Coping stone	
3	Chimney head	
4	Flashing	
5	Ridge ventilation	
6	Ridge board	
7	Slates/tiles	
8	Valley guttering	
9	Dormer projection	
10	Dormer flashing	
11	Dormer cheeks	
12	Sarking	
13	Roof felt	
14	Trusses	
15	Collar	
16	Insulation	
17	Parapet gutter	
18	Eaves guttering	
19	Rainwater downpipe	
20	Verge boards / skews	
21	Soffit boards	
22	Partition wall	
23	Lath / plaster	
24	Chimney breast	
25	Window pointing	
26	Window sills	
27	Rendering	
28	Brickwork / pointing	
29	Bay window	
	projection	
30	Lintels	
31	Cavity walls / wall ties	
32	Subfloor ventilator	
33	Damp proof course	
34	Base course	
35	Foundations	
36	Solum	
37	Floor joists	
38	Floorboards	
39	Water tank	
40	Hot water tank	
	-
