HOME REPORT

63A PORTLAND ROAD
KILMARNOCK
KA1 2EQ

Energy Performance Certificate (EPC)

63A PORTLAND ROAD, KILMARNOCK, KA1 2EQ

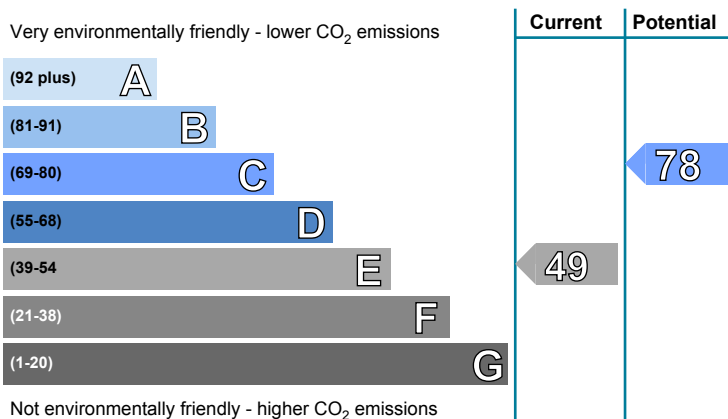
Environmental Impact (CO₂) Rating

This graph shows the effect of your home on the environment in terms of carbon dioxide (CO₂) emissions. The higher the rating, the less impact it has on the environment.

Your current rating is **band E (49)**. The average rating for EPCs in Scotland is **band D (59)**.

The potential rating shows the effect of undertaking all of the improvement measures listed within your recommendations report.
