HOME REPORT

7 STIRLING AVENUE BONNYTON KILMARNOCK KA1 2LD

SINGLE SURVEY

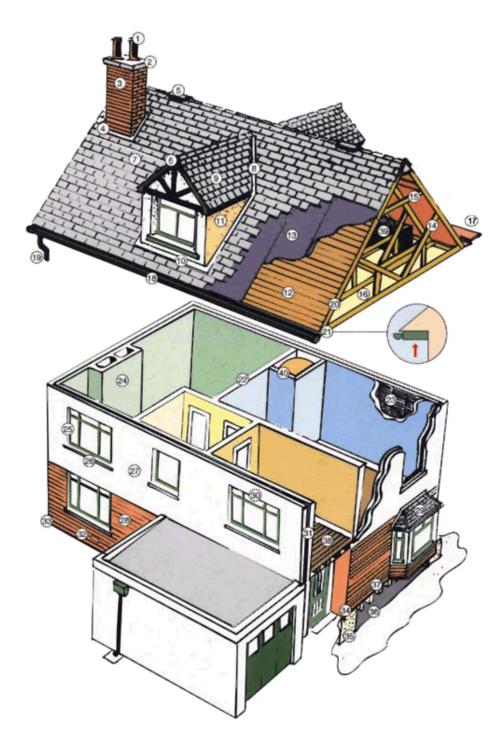
Sectional Diagram showing elements of a typical house

Reference may be made in this report to some or all of the above component parts of the property. This diagram may assist you in locating and understanding these items.

- 1) Chimney pots
- 2 Coping stone
- 3) Chimney head
- 4 Flashing
- 5) Ridge ventilation
- 6 Ridge board
- 7) Slates / tiles
- 8 Valley guttering
- 9 Dormer projection
- 10 Dormer flashing
- 11) Dormer cheeks
- (12) Sarking
- (13) Roof felt
- (14) Trusses
- 15) Collar
- (16) Insulation
- (17) Parapet gutter
- 18) Eaves guttering
- 19 Rainwater downpipe
- 20) Verge boards/skews
- 21) Soffit boards
- 22) Partition wall
- 23) Lath / plaster
- (24) Chimney breast
- (25) Window pointing
- 6) Window sills
- 27) Rendering
- (28) Brickwork / pointing
- 29) Bay window projection
- (30) Lintels
- (31) Cavity walls / wall ties
- 32) Subfloor ventilator
- 3) Damp proof course
- 34) Base course
- 35) Foundations
- (36) Solum
- 37) Floor joists
- 38) Floorboards
- 39) Water tank
- 40) Hot water tank
