# HOME REPORT

FLAT 2  
45 CROSSGATE  
CUPAR  
KY15 5AS

FLAT 2 , 45 CROSSGATE, CUPAR, KY15 5AS

**Dwelling type:** Top-floor maisonette  
**Date of assessment:** 28 July 2022  
**Date of certificate:** 01 August 2022  
**Total floor area:** 144 m<sup>2</sup>  
**Primary Energy Indicator:** 317 kWh/m<sup>2</sup>/year

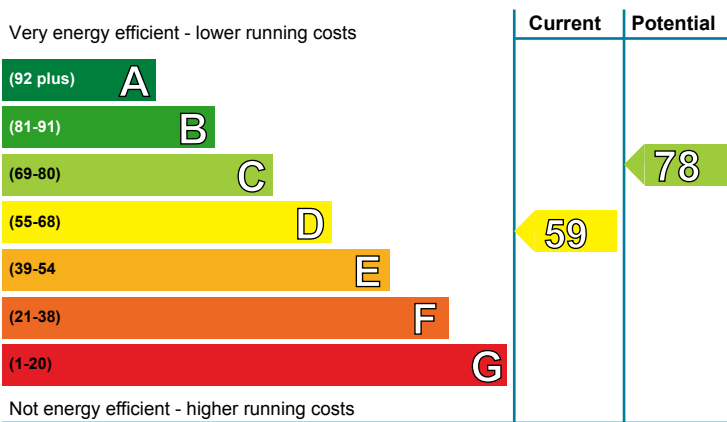
## Energy Efficiency Rating

This graph shows the current efficiency of your home, taking into account both energy efficiency and fuel costs. The higher this rating, the lower your fuel bills are likely to be.

Your current rating is **band D (59)**. The average rating for EPCs in Scotland is **band D (61)**.

The potential rating shows the effect of undertaking all of the improvement measures listed within your recommendations report.

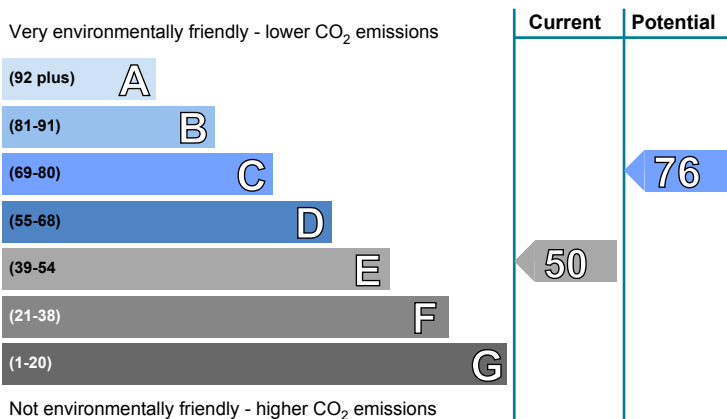
## Environmental Impact (CO<sub>2</sub>) Rating

This graph shows the effect of your home on the environment in terms of carbon dioxide (CO<sub>2</sub>) emissions. The higher the rating, the less impact it has on the environment.

Your current rating is **band E (50)**. The average rating for EPCs in Scotland is **band D (59)**.

The potential rating shows the effect of undertaking all of the improvement measures listed within your recommendations report.
