Home Report

39 Old Glasgow Road Stewarton KA3 5JJ

Single Survey

Property Address	39 Old Glasgow Road Stewarton KA3 5JJ
Customer	Jim Moser
Prepared by	Graham + Sibbald LLP
Date of Inspection	01/04/2025

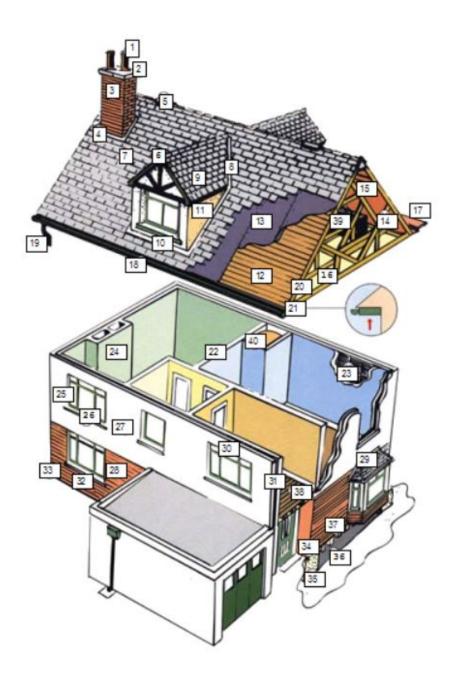
Sectional diagram showing elements of a typical house

1	Chimney pots
2	Coping stone
3	Chimney head
4	Flashing
5	Ridge ventilation
6	Ridge board
7	Slates / tiles
8	Valley guttering
9	Dormer projection
10	Dormer flashing
11	Dormer cheeks
12	Sarking
13	Roof felt
14	Trusses
15	Collar
16	Insulation
17	Parapet gutter
18	Eaves guttering
19	Rainwater downpipe
20	Verge boards / skews
21	Soffit boards
22	Partition wall
23	Lath / plaster
24	Chimney breast
25	Window pointing
26	Window sills
27	Rendering
28	Brickwork / pointing
29	Bay window projection
30	Lintels
31	Cavity walls / wall ties
32	Subfloor ventilator
33	Damp proof course
34	Base course
35	Foundations
36	Solum
37	Floor joists
38	Floorboards
39	Water tank
40	Hot water tank

Reference may be made in this report to some or all of the above component parts of the property. This diagram may assist you in locating and understanding these items.
