HOME REPORT

BENFIELD LOSSET ROAD

ALYTH
BLAIRGOWRIE
PH11 8BU

Single Survey

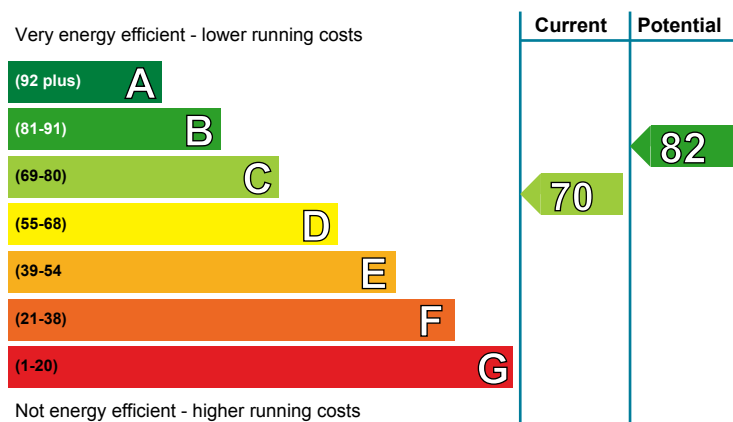
Energy Efficiency Rating

This graph shows the current efficiency of your home, taking into account both energy efficiency and fuel costs. The higher this rating, the lower your fuel bills are likely to be.

Your current rating is **band C (70)**. The average rating for EPCs in Scotland is **band D (61)**.

The potential rating shows the effect of undertaking all of the improvement measures listed within your recommendations report.

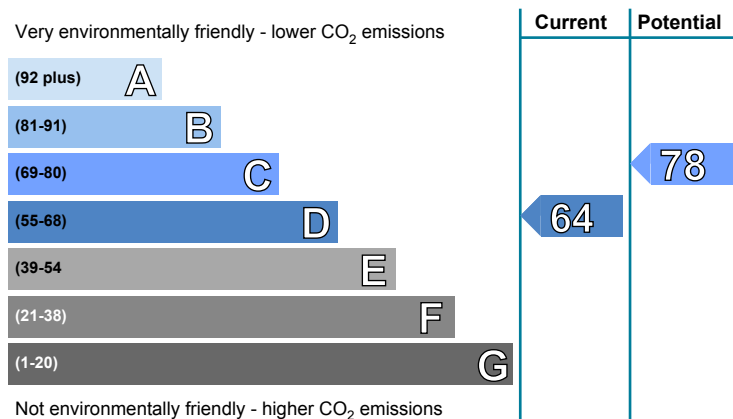
Environmental Impact (CO₂) Rating

This graph shows the effect of your home on the environment in terms of carbon dioxide (CO₂) emissions. The higher the rating, the less impact it has on the environment.

Your current rating is **band D (64)**. The average rating for EPCs in Scotland is **band D (59)**.

The potential rating shows the effect of undertaking all of the improvement measures listed within your recommendations report.
