# Home Report

5 Dykehead Drive  
Hurlford KA1 5DJ

Date of Valuation: 23/04/2025

# Single Survey

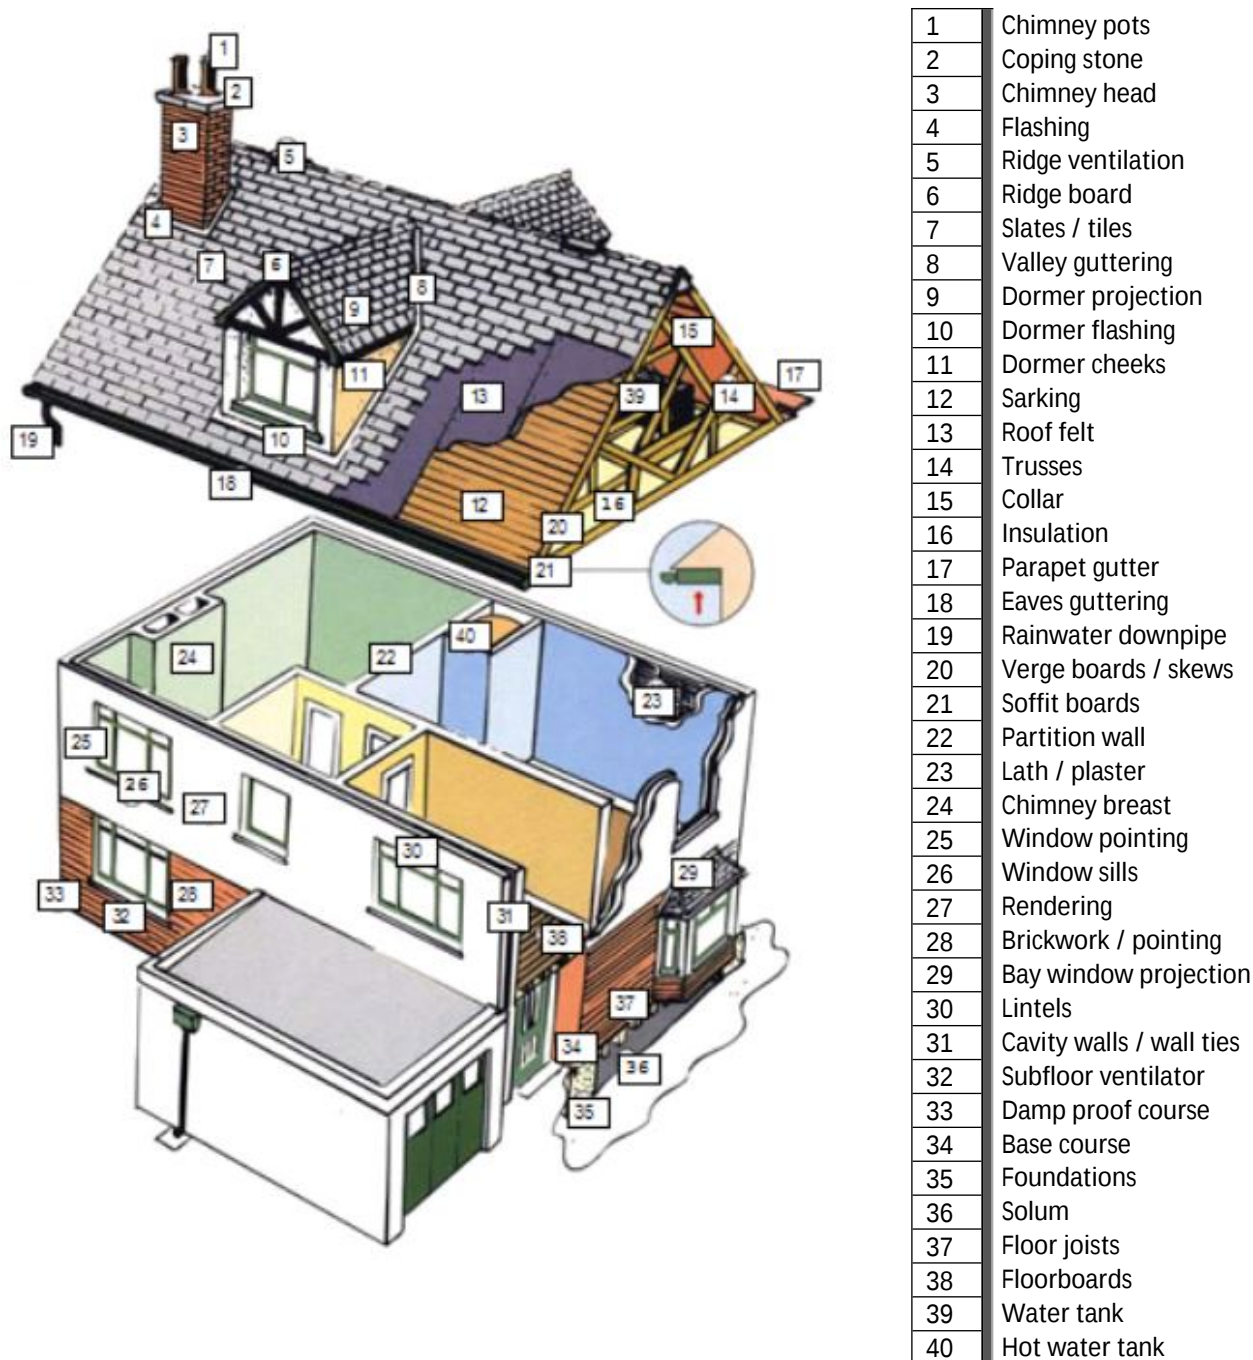
## Sectional diagram showing elements of a typical house

Reference may be made in this report to some or all of the above component parts of the property. This diagram may assist you in locating and understanding these items.
