Home Report

Single Survey

1 Spey Avenue,
Kilmarnock,
KA1 3PG

SINGLE SURVEY TERMS AND CONDITIONS (WITH MVR)

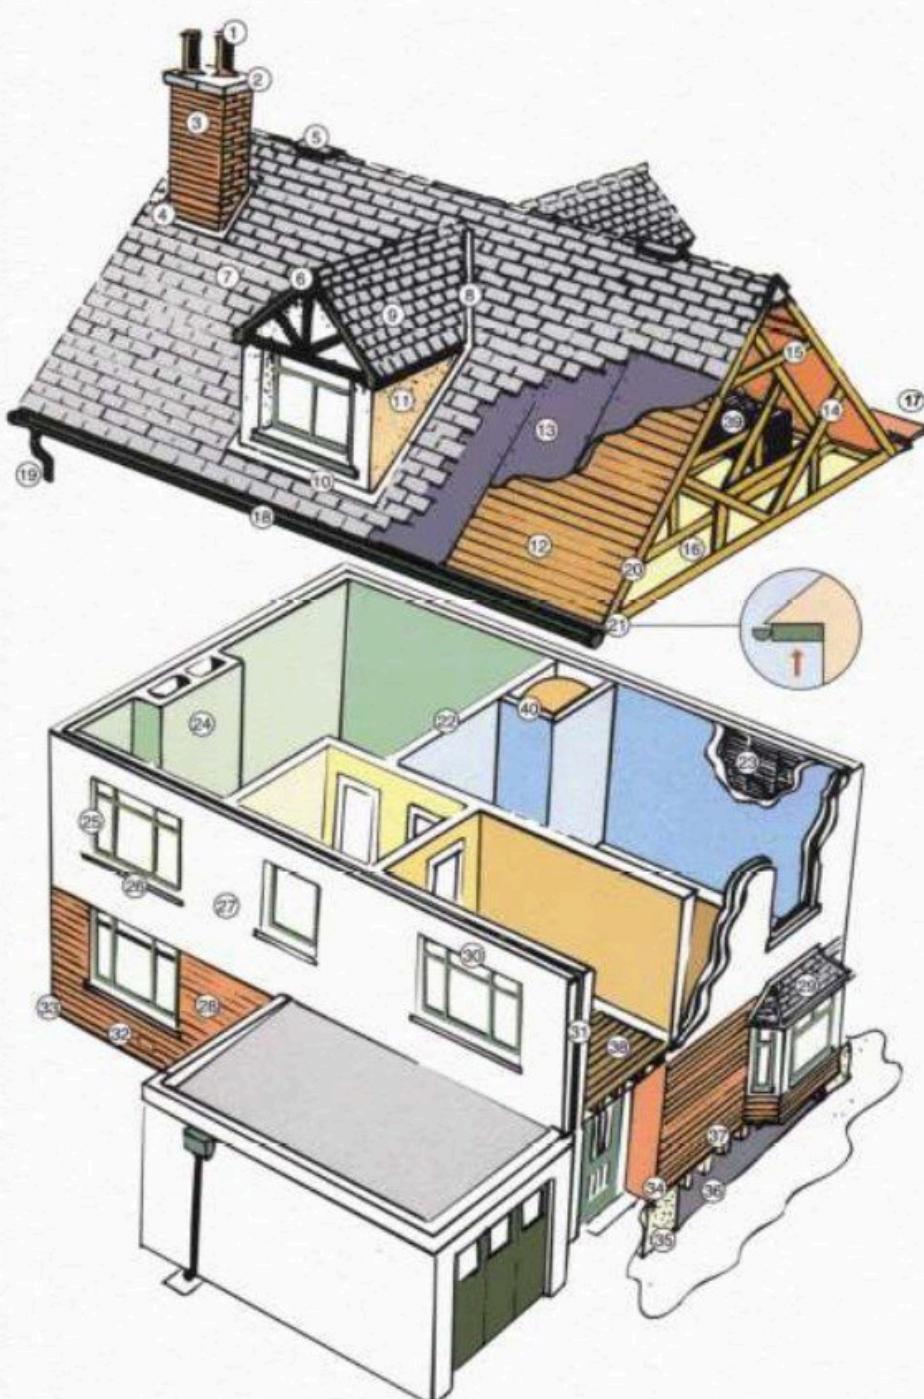
Sectional Diagram showing elements of a typical house

- 1 Chimney pots
- 2 Coping stone
- 3 Chimney head
- 4 Flashing
- 5 Ridge ventilation
- 6 Ridge board
- 7 Slates / tiles
- 8 Valley guttering
- 9 Dormer projection
- 10 Dormer flashing
- 11 Dormer cheeks
- 12 Sarking
- 13 Roof felt
- 14 Trusses
- 15 Collar
- 16 Insulation
- 17 Parapet gutter
- 18 Eaves guttering
- 19 Rainwater downpipe
- 20 Verge boards / skewers
- 21 Soffit boards
- 22 Partition wall
- 23 Lath / plaster
- 24 Chimney breast
- 25 Window pointing
- 26 Window sills
- 27 Rendering
- 28 Brickwork / pointing
- 29 Bay window projection
- 30 Lintels
- 31 Cavity walls / wall ties
- 32 Subfloor ventilator
- 33 Damp proof course
- 34 Base course
- 35 Foundations
- 36 Solum
- 37 Floor joists
- 38 Floorboards
- 39 Water tank
- 40 Hot water tank

Reference may be made in this report to some or all of the above component parts of the property. This diagram may assist you in locating and understanding these items.
