Home Report

Fairview,
4 Newtyle Road,
Kettins,
BLAIRGOWRIE,
Perthshire,
PH13 9JJ

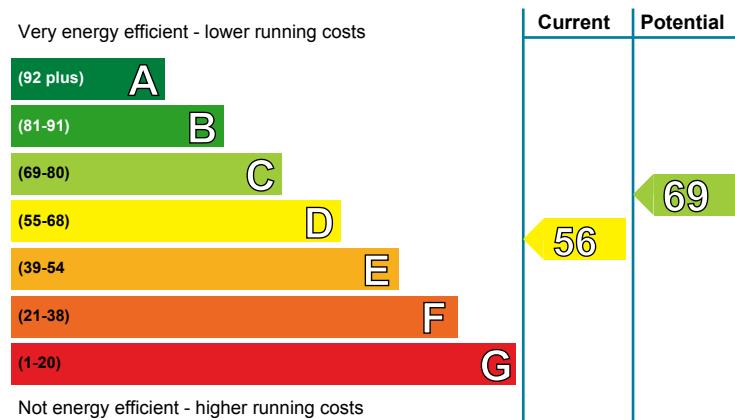
Energy Efficiency Rating

This graph shows the current efficiency of your home, taking into account both energy efficiency and fuel costs. The higher this rating, the lower your fuel bills are likely to be.

Your current rating is **band D (56)**. The average rating for EPCs in Scotland is **band D (61)**.

The potential rating shows the effect of undertaking all of the improvement measures listed within your recommendations report.

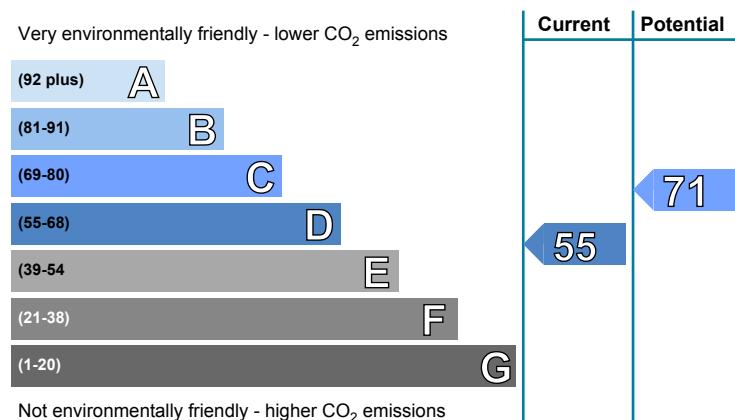
Environmental Impact (CO₂) Rating

This graph shows the effect of your home on the environment in terms of carbon dioxide (CO₂) emissions. The higher the rating, the less impact it has on the environment.

The potential rating shows the effect of undertaking all of the improvement measures listed within your recommendations report.
