HOME REPORT

26 CHACEFIELD STREET
BONNYBRIDGE
FK4 1PS

26 CHACEFIELD STREET, BONNYBRIDGE, FK4 1PS

Dwelling type: End-terrace house
Date of assessment: 27 March 2024
Date of certificate: 27 March 2024
Total floor area: 67 m²
Primary Energy Indicator: 312 kWh/m²/year

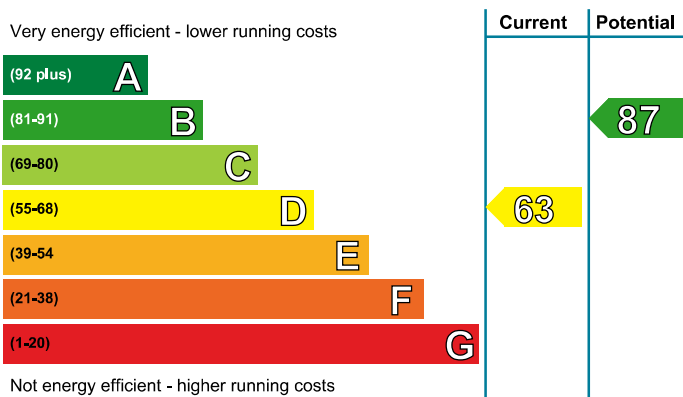
Energy Efficiency Rating

This graph shows the current efficiency of your home, taking into account both energy efficiency and fuel costs. The higher this rating, the lower your fuel bills are likely to be.

Your current rating is **band D (63)**. The average rating for EPCs in Scotland is **band D (61)**.

The potential rating shows the effect of undertaking all of the improvement measures listed within your recommendations report.

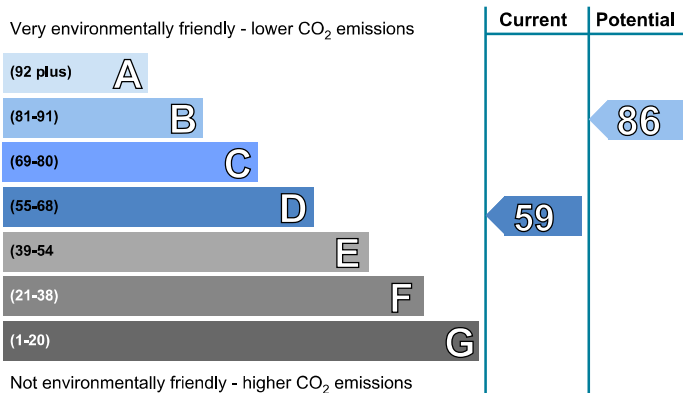
Environmental Impact (CO₂) Rating

This graph shows the effect of your home on the environment in terms of carbon dioxide (CO₂) emissions. The higher the rating, the less impact it has on the environment.

Your current rating is **band D (59)**. The average rating for EPCs in Scotland is **band D (59)**.

The potential rating shows the effect of undertaking all of the improvement measures listed within your recommendations report.

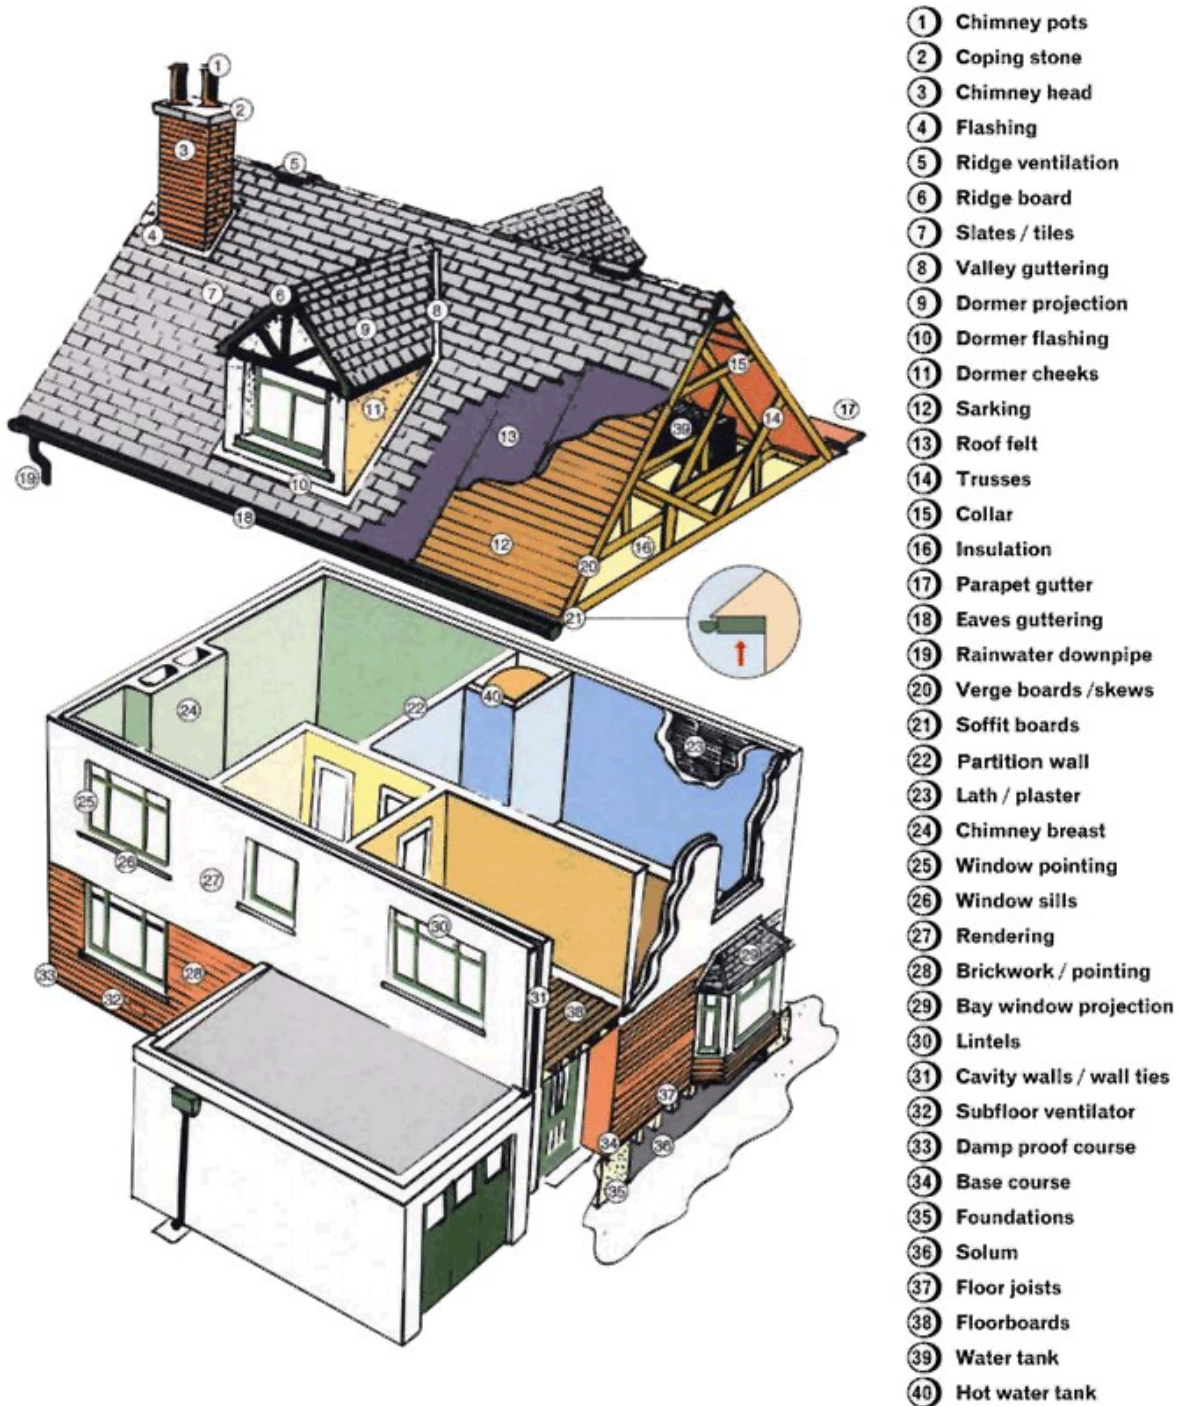
Sectional Diagram showing elements of a typical house

Reference may be made in this report to some or all of the above component parts of the property. This diagram may assist you in locating and understanding these items.
