# Home Report

Flat 2  
93 Main Street  
Callander  
FK17 8BQ

# single survey

<b>Property address</b>	Flat 2 93 Main Street Callander FK17 8BQ
<b>Customer</b>	Fiona Perkins
<b>Prepared by</b>	Graham + Sibbald LLP

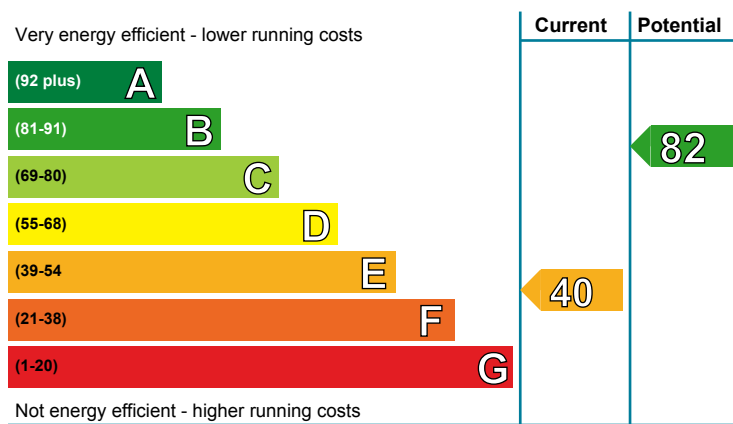
## Energy Efficiency Rating

This graph shows the current efficiency of your home, taking into account both energy efficiency and fuel costs. The higher this rating, the lower your fuel bills are likely to be.

Your current rating is **band E (40)**. The average rating for EPCs in Scotland is **band D (61)**.

The potential rating shows the effect of undertaking all of the improvement measures listed within your recommendations report.
