# Home Report

# Single Survey

## Survey Report on:

| <b>Property Address</b> | 30 C London Road,<br>Kilmarnock,<br>East Ayrshire,<br>KA3 7AQ |

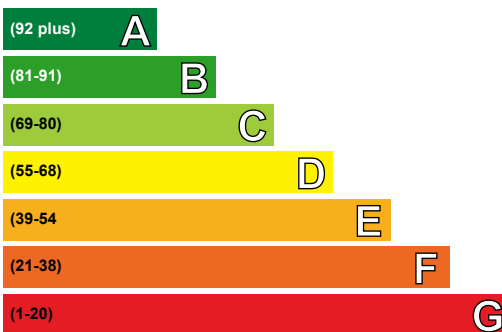
Very energy efficient - lower running costs

Not energy efficient - higher running costs

The potential rating shows the effect of undertaking all of the improvement measures listed within your recommendations report.

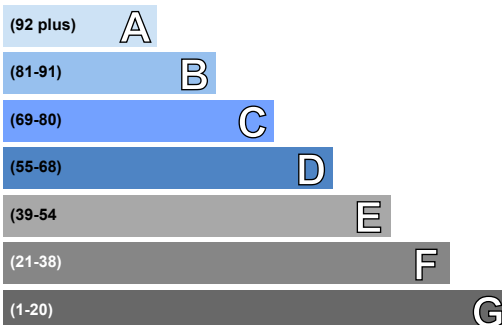
Very environmentally friendly - lower CO<sub>2</sub> emissions

Not environmentally friendly - higher CO<sub>2</sub> emissions
