# espc::home report

9 Durward Grove  
EDINBURGH  
EH16 5RS  
21/03/2018

# Single Survey

<b>Property address</b>	9 Durward Grove, Edinburgh, EH16 5RS
-------------------------	--

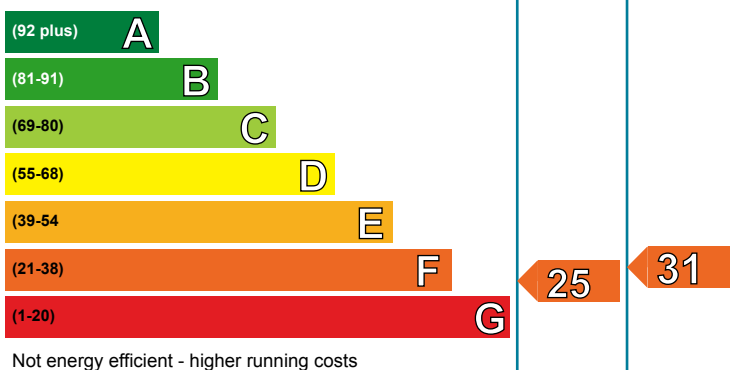
## Energy Efficiency Rating

This graph shows the current efficiency of your home, taking into account both energy efficiency and fuel costs. The higher this rating, the lower your fuel bills are likely to be.

The potential rating shows the effect of undertaking all of the improvement measures listed within your recommendations report.

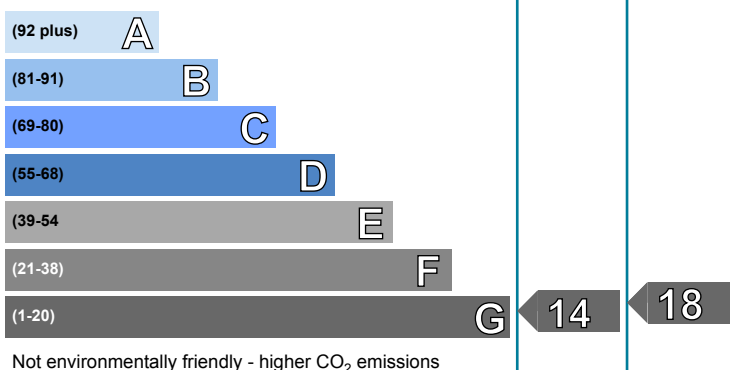
## Environmental Impact (CO<sub>2</sub>) Rating

This graph shows the effect of your home on the environment in terms of carbon dioxide (CO<sub>2</sub>) emissions. The higher the rating, the less impact it has on the environment.
