# Home Report

24 Main Street  
Craigie Kilmarnock KA1 5LY

# Single Survey

| Prepared by | Graham + Sibbald LLP |

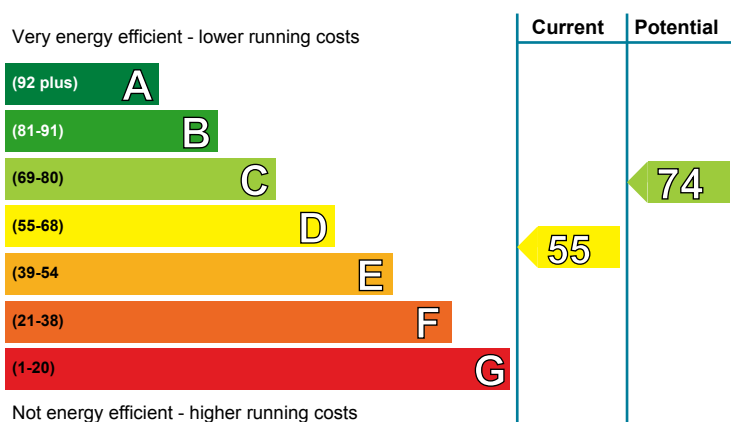
## Energy Efficiency Rating

This graph shows the current efficiency of your home, taking into account both energy efficiency and fuel costs. The higher this rating, the lower your fuel bills are likely to be.

Your current rating is **band D (55)**. The average rating for EPCs in Scotland is **band D (61)**.

The potential rating shows the effect of undertaking all of the improvement measures listed within your recommendations report.

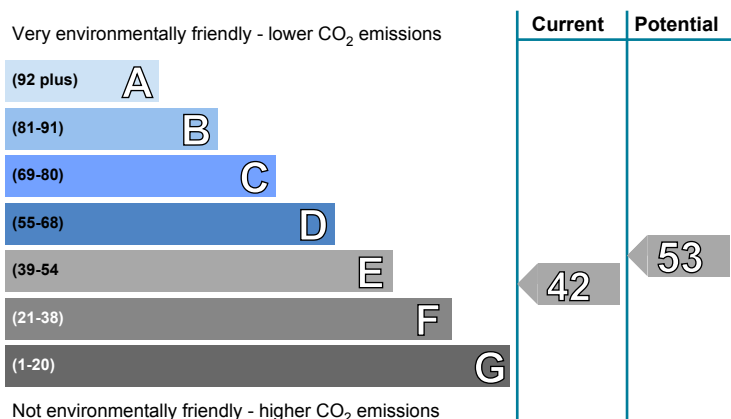
## Environmental Impact (CO<sub>2</sub>) Rating

This graph shows the effect of your home on the environment in terms of carbon dioxide (CO<sub>2</sub>) emissions. The higher the rating, the less impact it has on the environment.
