YOUR ONESURVEY HOME REPORT

Flat 20/6 St. Katharine's Crescent Edinburgh EH16 6PU

Single Survey

Date of Inspection	25/04/2025
Prepared by	Lyndsay Gowans, MRICS
	DHKK Ltd

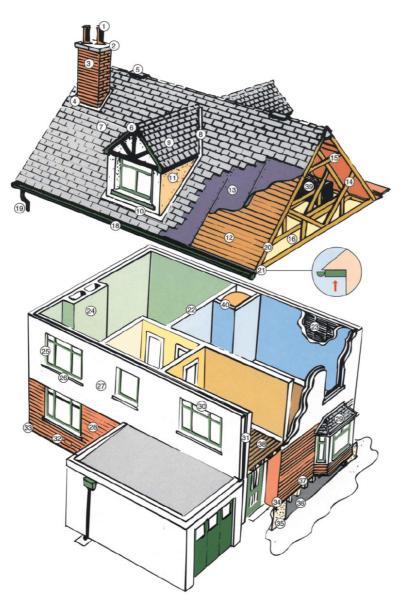
Sectional Diagram showing elements of a typical house

Reference may be made in this report to some or all of the above component parts of the property. This diagram may assist you in locating and understanding these items.

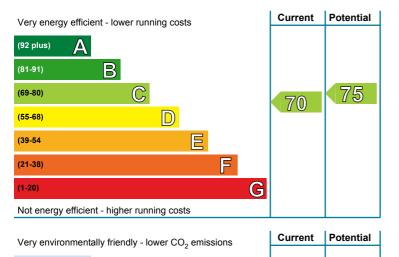
Energy Efficiency Rating

This graph shows the current efficiency of your home, taking into account both energy efficiency and fuel costs. The higher this rating, the lower your fuel bills are likely to be.
