YOUR ONESURVEY  
**HOME REPORT**

82 Parkhead Loan  
Edinburgh  
EH11 4SN

# SINGLE SURVEY

A report on the condition of the property, with categories being rated from 1 to 3.

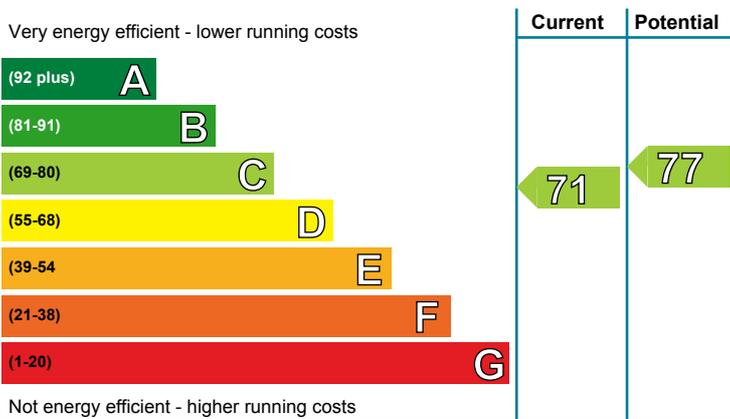
## Energy Efficiency Rating

This graph shows the current efficiency of your home, taking into account both energy efficiency and fuel costs. The higher this rating, the lower your fuel bills are likely to be.

Your current rating is **band C (71)**. The average rating for EPCs in Scotland is **band D (61)**.

The potential rating shows the effect of undertaking all of the improvement measures listed within your recommendations report.

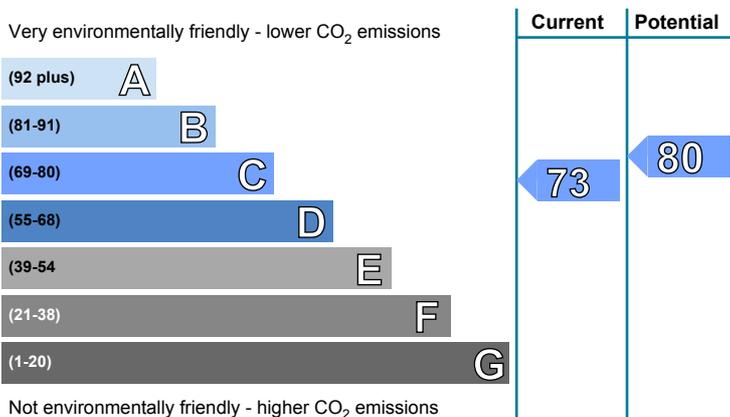
## Environmental Impact (CO<sub>2</sub>) Rating

This graph shows the effect of your home on the environment in terms of carbon dioxide (CO<sub>2</sub>) emissions. The higher the rating, the less impact it has on the environment.
