Home Report

Scottish
Single Survey

Property address	33 Craighall Road Kilmarnock KA3 6GN
Customer	Scott Sutherland
Customer address	33 Craighall Road Kilmarnock KA3 6GN
Prepared by	Shepherd Chartered Surveyors
Date of inspection	09/05/2025

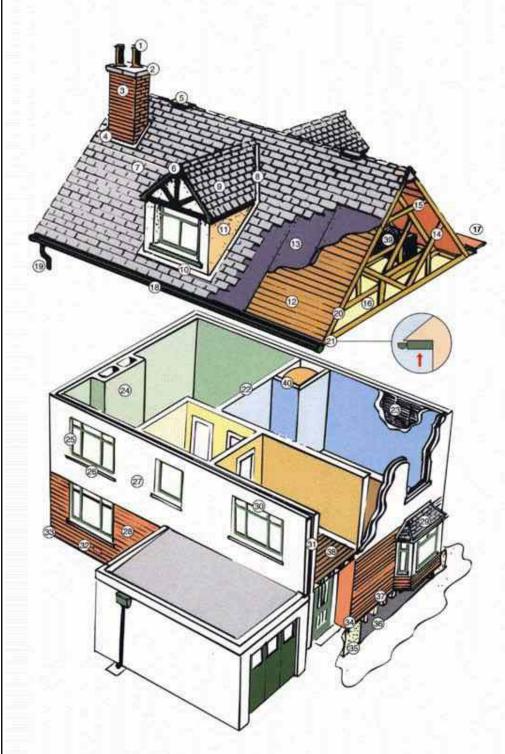
Sectional Diagram showing elements of a typical house

Reference may be made in this report to some or all of the above component parts of the property. This diagram may assist you in locating and understanding these items.

- 1) Chimney pots
- 2) Coping stone
- 3 Chimney head
- (4) Flashing
- 5) Ridge ventilation
- (6) Ridge board
- 7 Slates / tiles
- 8 Valley guttering
- Dormer projection
- 10) Dormer flashing
- 11) Dormer cheeks
- (12) Sarking
- (13) Roof felt
- 14) Trusses
- 15) Collar
- 16) Insulation
- (17) Parapet gutter
- 18) Eaves guttering
- (19) Rainwater downpipe
- 20) Verge boards/skews
- 21) Soffit boards
- 22) Partition wall
- 23) Lath / plaster
- (24) Chimney breast
- 25) Window pointing
- 26) Window sills
- 27) Rendering
- (28) Brickwork / pointing
- 29) Bay window projection
- (30) Lintels
- (31) Cavity walls / wall ties
- 32) Subfloor ventilator
- (33) Damp proof course
- 34) Base course
- (35) Foundations
- 36) Solum
- Floor joists
- 38) Floorboards
- 39) Water tank
- (40) Hot water tank
