Home Report

Scottish Single Survey

Property address	15 Wilson Avenue Irvine KA12 0TW
-------------------------	--

Date of inspection	07/04/2026
---------------------------	------------

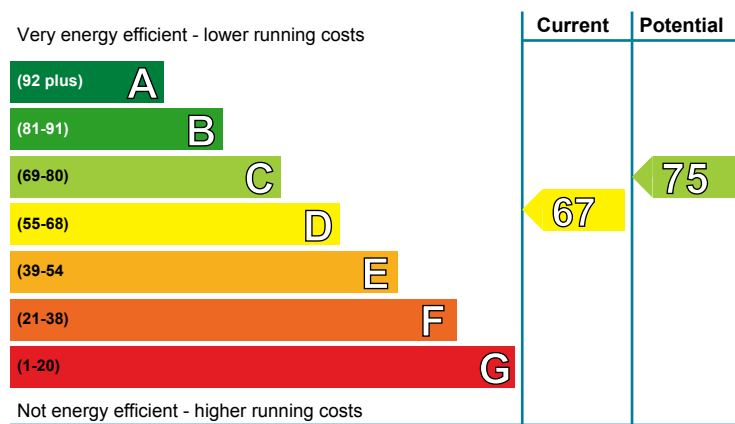
Energy Efficiency Rating

This graph shows the current efficiency of your home, taking into account both energy efficiency and fuel costs. The higher this rating, the lower your fuel bills are likely to be.

Your current rating is **band D (67)**. The average rating for EPCs in Scotland is **band D (61)**.

The potential rating shows the effect of undertaking all of the improvement measures listed within your recommendations report.

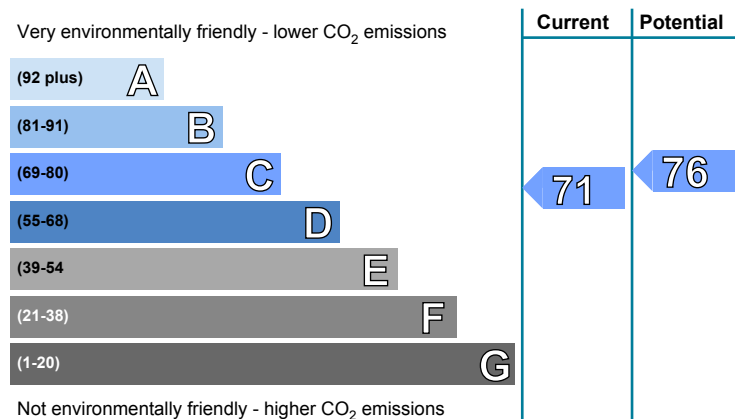
Environmental Impact (CO₂) Rating

This graph shows the effect of your home on the environment in terms of carbon dioxide (CO₂) emissions. The higher the rating, the less impact it has on the environment.
