Home Report

3H Isles Street Newmilns KA16 9DP

single survey

survey report on:

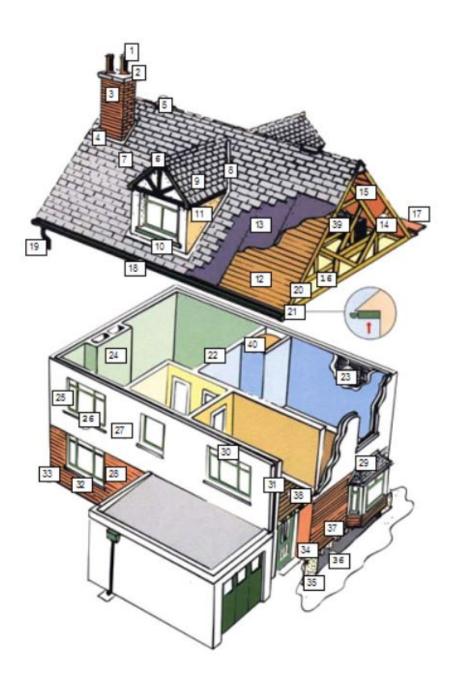
Sectional Diagram showing elements of a typical house

- Chimney pots
- 2 Coping stone
- 3 Chimney head
- Flashing 4
- Ridge ventilation
- Ridge board
- Slates/tiles
- Valley guttering 8
- Dormer projection 9
- 10 Dormer flashing
- 11 Dormer cheeks
- 12 Sarking
- Roof felt 13
- Trusses 14
- 15 Collar
- Insulation 16
- Parapet gutter 17
- Eaves guttering 18
- 19 Rainwater downpipe
- 20 Verge boards / skews
- Soffit boards 21
- Partition wall 22
- Lath / plaster 23
- 24 Chimney breast
- 25 Window pointing
- Window sills
- 26
- Rendering 27
- Brickwork / pointing 28
- window Bay 29
 - projection
- 30 Lintels
- Cavity walls / wall ties 31
- Subfloor ventilator 32
- Damp proof course 33
- Base course 34
- 35 **Foundations**
- Solum 36
- 37 Floor joists
- 38 Floorboards
- 39 Water tank
- 40 Hot water tank

Reference may be made in this report to some or all of the above component parts of the property. This diagram may assist you in locating and understanding these items.
