4 Primary Court,
Glebe Road,
Galston,
East Ayrshire,
KA4 8EY

Home Report

Single Survey

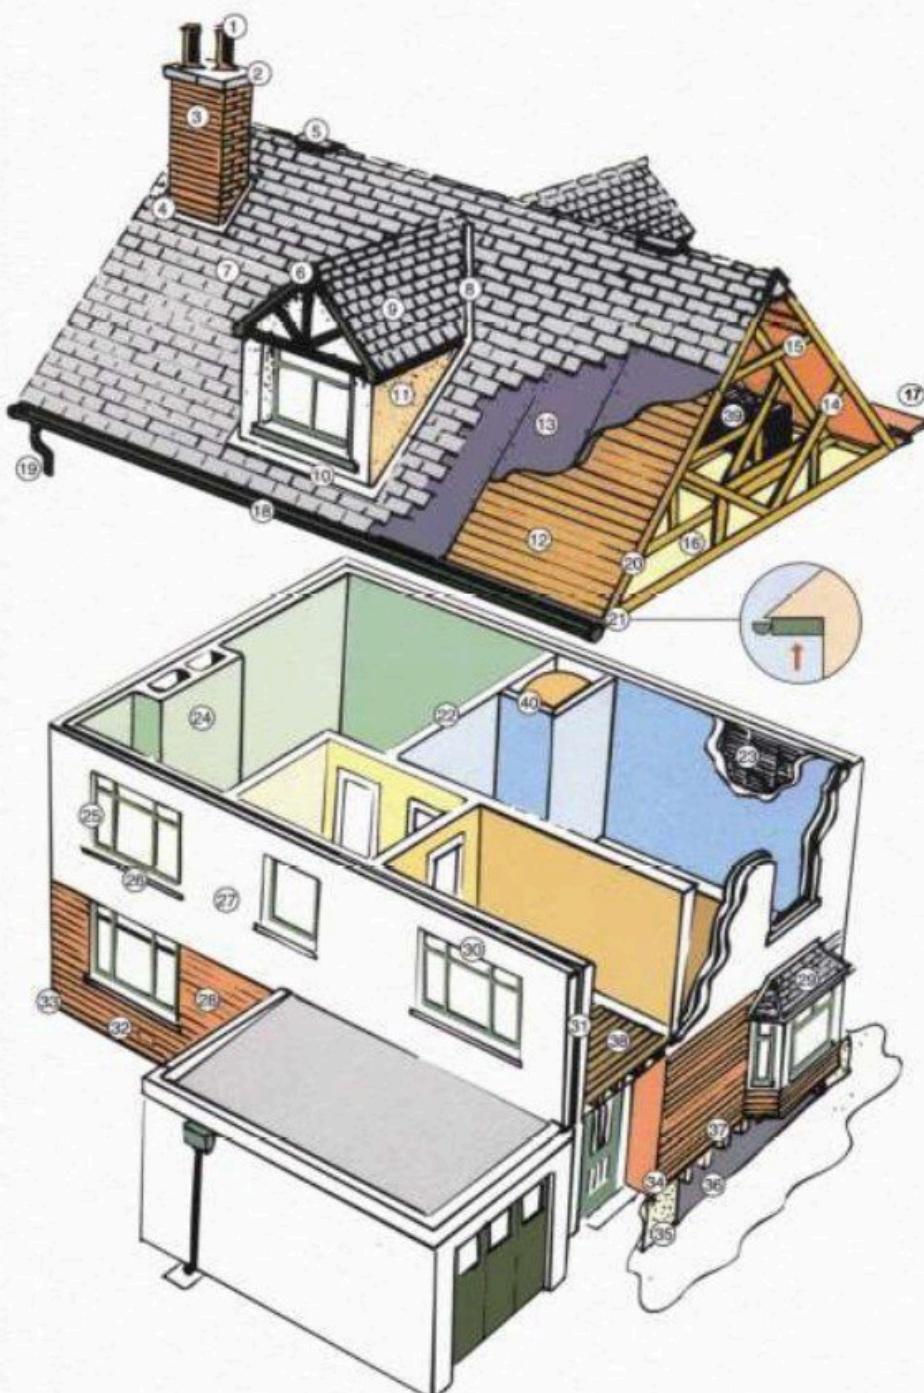
Sectional Diagram showing elements of a typical house

- 1 Chimney pots
- 2 Coping stone
- 3 Chimney head
- 4 Flashing
- 5 Ridge ventilation
- 6 Ridge board
- 7 Slates / tiles
- 8 Valley guttering
- 9 Dormer projection
- 10 Dormer flashing
- 11 Dormer cheeks
- 12 Sarking
- 13 Roof felt
- 14 Trusses
- 15 Collar
- 16 Insulation
- 17 Parapet gutter
- 18 Eaves guttering
- 19 Rainwater downpipe
- 20 Verge boards / skewers
- 21 Soffit boards
- 22 Partition wall
- 23 Lath / plaster
- 24 Chimney breast
- 25 Window pointing
- 26 Window sills
- 27 Rendering
- 28 Brickwork / pointing
- 29 Bay window projection
- 30 Lintels
- 31 Cavity walls / wall ties
- 32 Subfloor ventilator
- 33 Damp proof course
- 34 Base course
- 35 Foundations
- 36 Solum
- 37 Floor joists
- 38 Floorboards
- 39 Water tank
- 40 Hot water tank

Reference may be made in this report to some or all of the above component parts of the property. This diagram may assist you in locating and understanding these items.
